**Neath Port Talbot County Borough Council
Cyngor Bwrdeistref Sirol Castell-nedd**

**Democratic Services
Gwasanaethau Democrataidd**

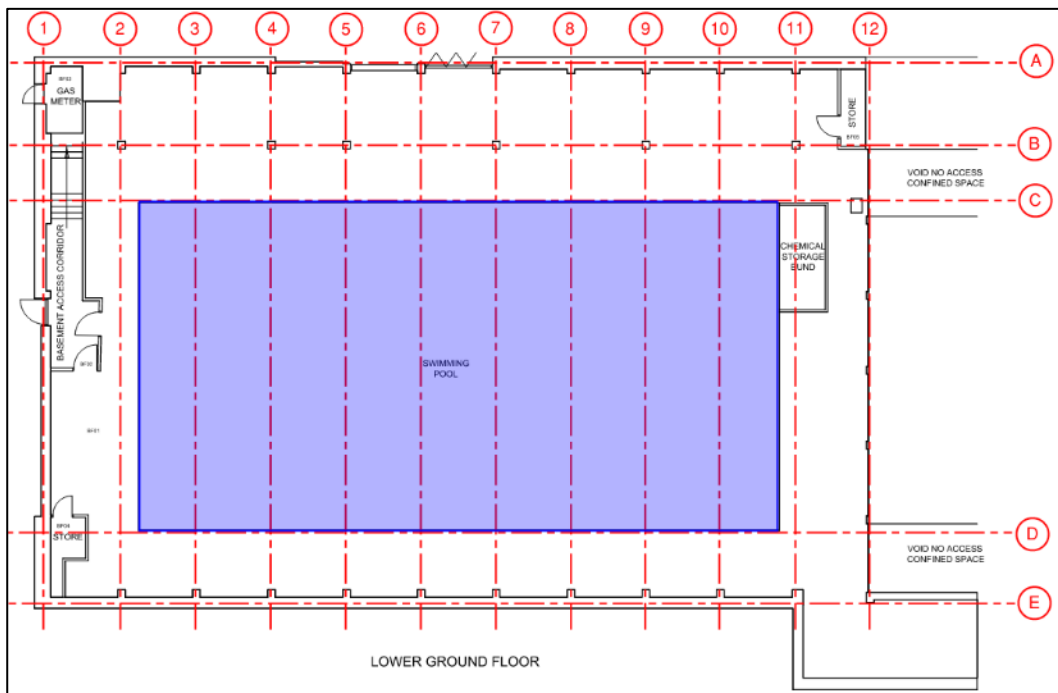
Figure 1 – Plan of Basement area around main pool – note gridlines added for the purposes of referencing in this report only

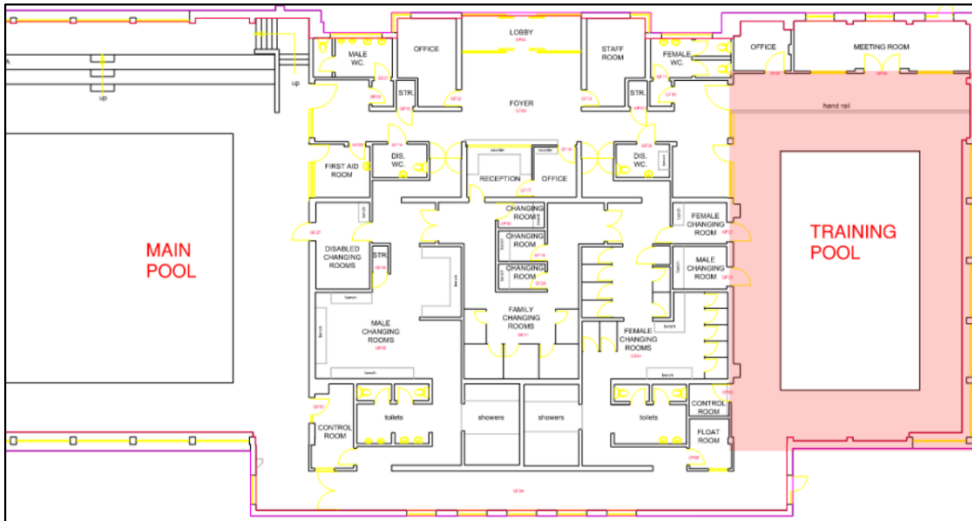
Figure 2 – Part-plan of facility with area surveyed by CRL highlighted red

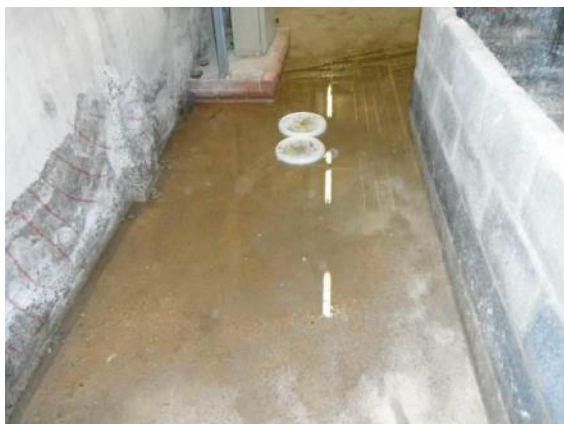
Figure 3 - Standing water present during CRL 2014 survey

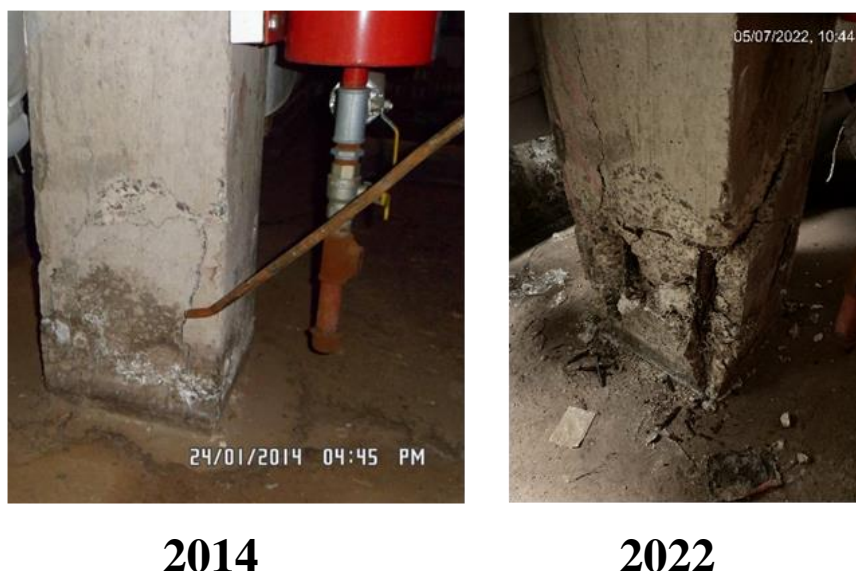
Figure 4 – Basement column spalling 2014 vs 2022 (Column B/2)

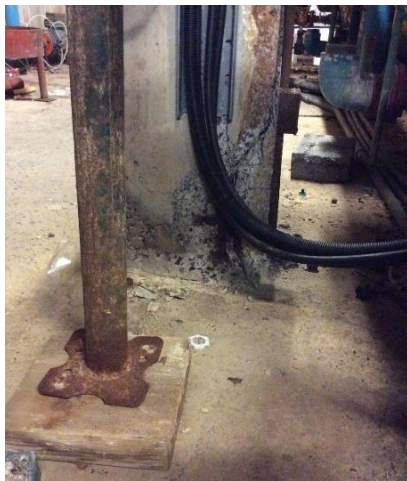
Figure 5 - Basement column spalling 2014 vs 2022 (Column B/4)

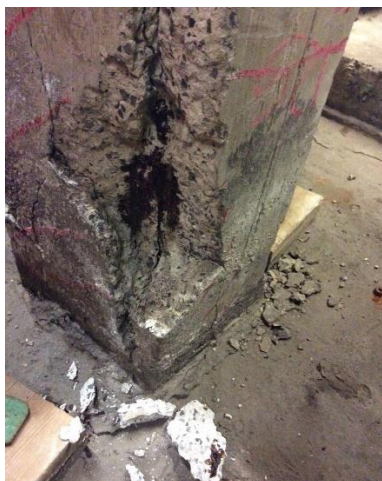
Figure 6 - Exponential degradation of basement columns 2020 vs 2022 with severe additional cracking (Column B/9)

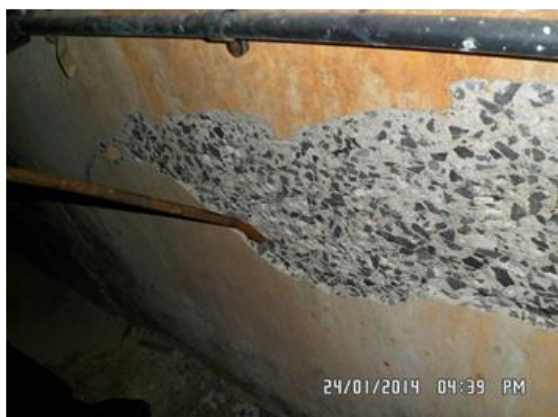
Figure 8 below highlights the level of degradation in other areas since 2014, with increased areas/depth of delamination clearly evident on the pool walls. This delamination and spalling of concrete however is not only localised to the pool wall but is also observed in several other areas of the plant room such as the external retaining walls and the concrete soffits. In all cases this delamination will have an impact on the resulting integrity of the structure.

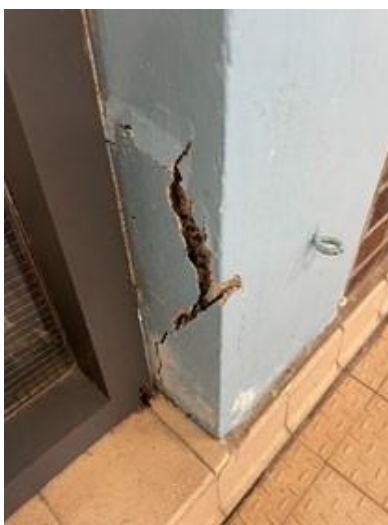
Figure 9 - Concrete deterioration advancing into in new areas not previously seen prior to 2022

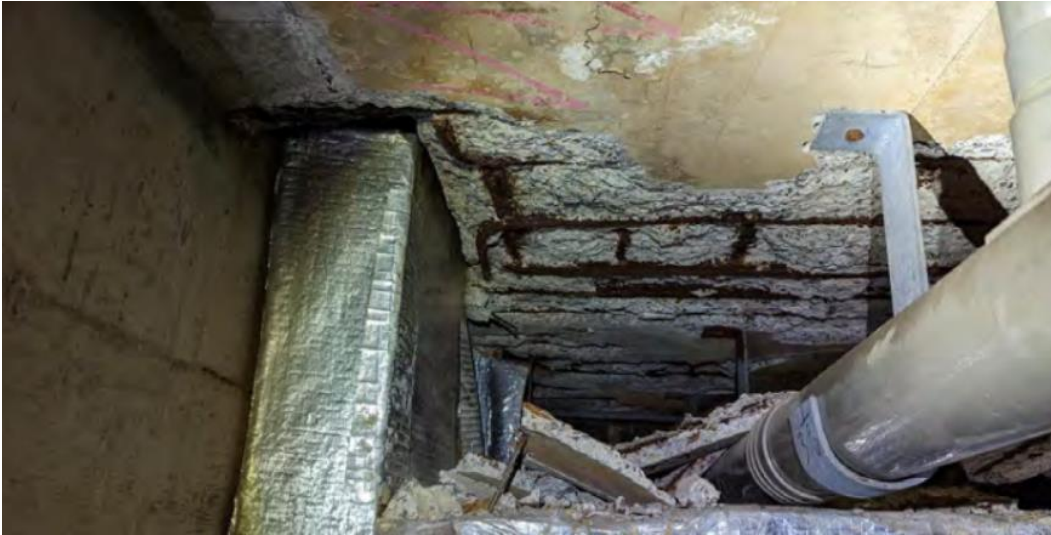
Figure 12 – Extension of defects previously identified in 2014 survey

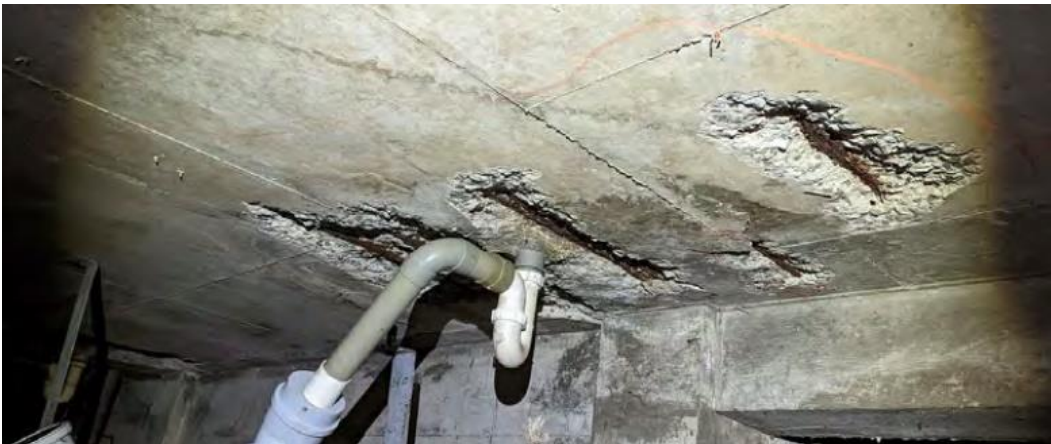
Figure 13 – Additional loose concrete, identified during hammer testing, marked in orange

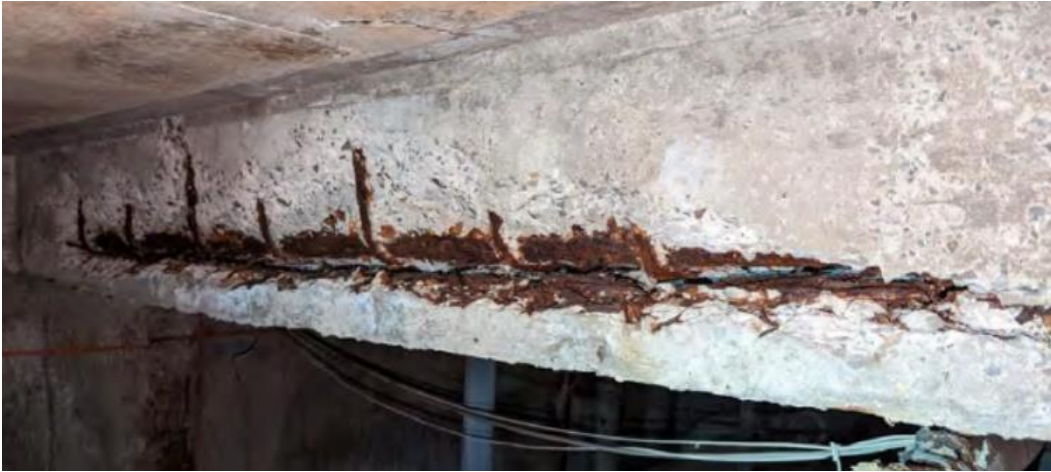
Figure 14 – Extensive spalling to the soffit of a beam showing extensive corrosion and the potential for cover to be lost

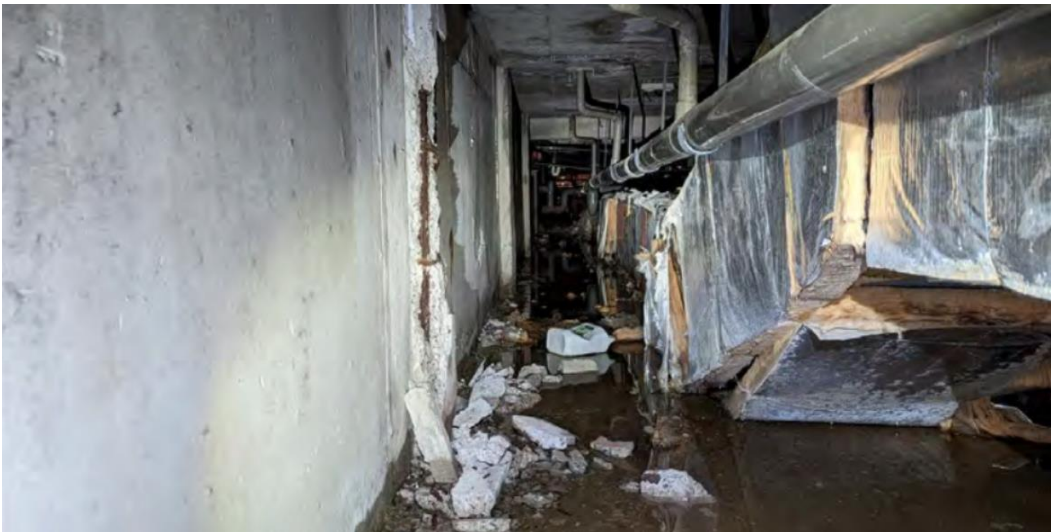
Figure 15 – Photo from CRL report. This appears to be a column located on Wall G and demonstrated significant section loss

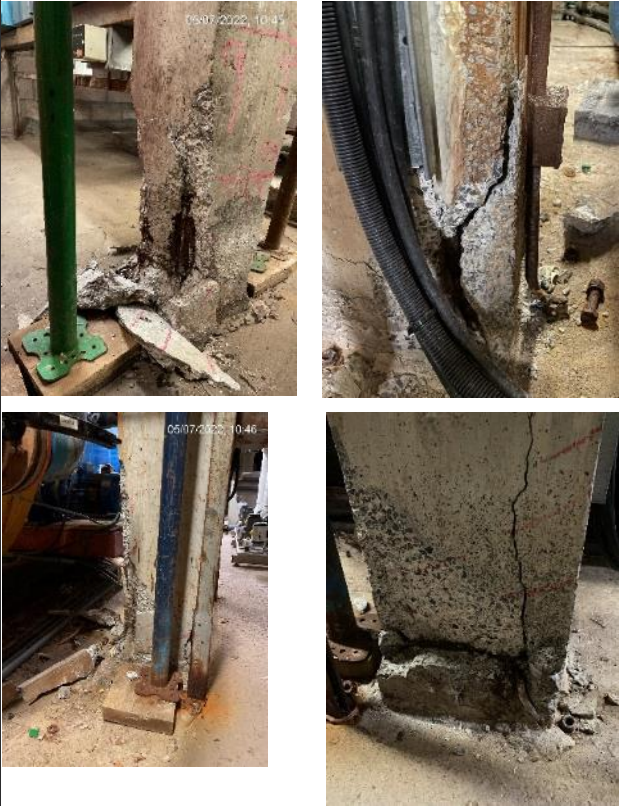
<p>Column reinforcement exposed. Severe spalling / delamination / cracking of concrete.</p> <p>Very large chunks of loose concrete spalling.</p> <p>Health and safety risk from loose concrete.</p> <p>Loss of cross-section and reduction in column load bearing capacity.</p> <p>Additional Acrow props have been installed adjacent to worst case affected columns.</p>	<p>Affected structure to be removed back to sound concrete. New reinforcement to be spliced in and column re-formed to original dimensions.</p>

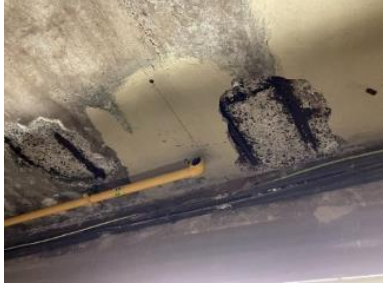
<p>Concrete spalling and exposed reinforcement to soffit.</p>	<p>Lose concrete to be removed. Exposed reinforcement to be cleaned, painted and concrete repaired using a proprietary repair product.</p>
<p>PS.03.</p>	<p>Basement Plant Room</p>

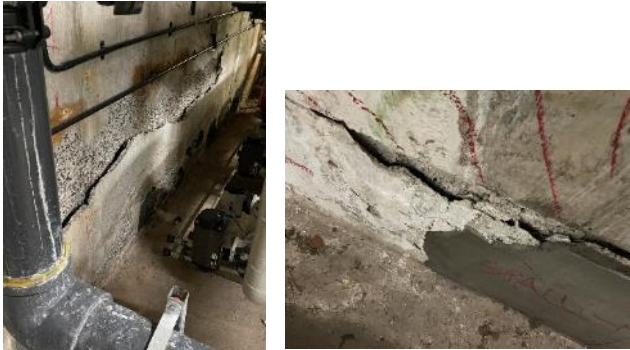
<p>Damage to concrete pool walls, spalled/delaminated concrete and some exposed reinforcement.</p>	<p>Loose concrete to be removed, Exposed reinforcement to be cleaned, painted and concrete repaired using a proprietary repair product.</p>
<p>PS.04.</p>	<p>Basement Plant Room & Poolside Slab</p>

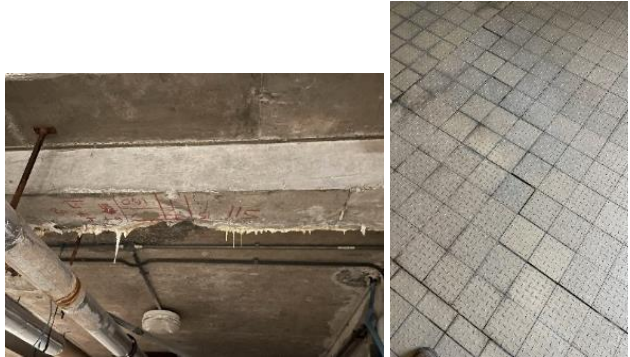
<p>Concrete beam in plant room with significant build-up of surface deposits beneath an area of defective / disrupted tiling on the poolside slab, with missing pointing / jointing. Evidence of longstanding historic leak and water ingress from above.</p>	<p>Repair defective tiling / pointing, check water tightness of repair. Remove surface deposits from beam and clean. Repair where necessary.</p>

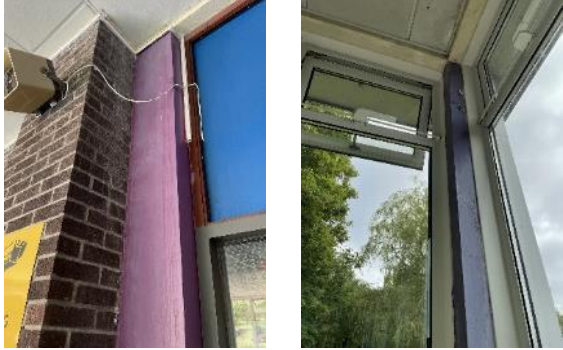
<p>Evidence of water ingress due to roof leaks which, if not addressed, will continue to degrade the concrete.</p>	<p>Urgent repairs required to roof/eaves/windows to prevent ingress of water leading to further structural damage.</p>
<p>PS.06.</p>	<p>Building Envelope</p>

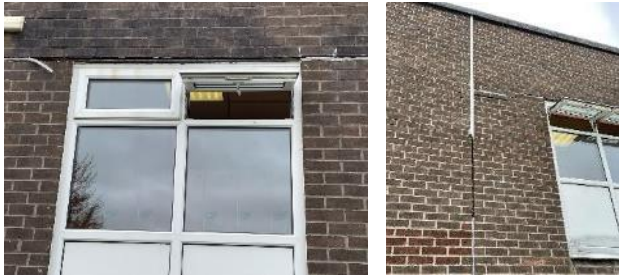
<p>Whilst not strictly covered by this concrete condition report, significant cracking to the masonry was noted during a walk over externally. As evidenced by the photographs, the brickwork above the openings on the rear elevation 'appears' to have raised. This could be the result of steel lintels expanding due to corrosion. Further investigation and monitoring of this is recommended.</p>	<p>Carry out investigation into potential cause of movement and monitor the extent of movement through crack monitoring devices.</p>

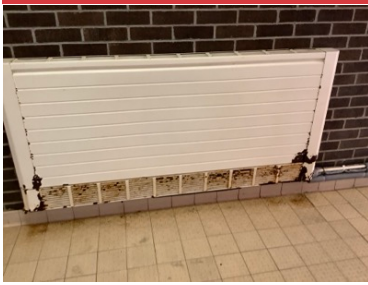
CORROSION OF M&E SERVICES FIXTURES & FITTINGS

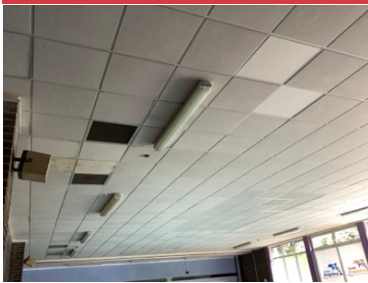
General corrosion to fixtures and fittings within swimming and changing room pool areas

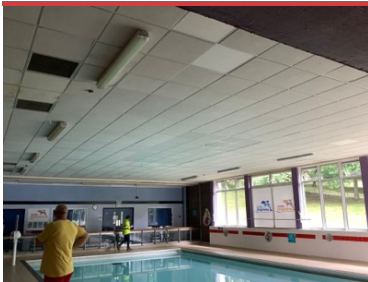
Upstairs on roof supporting extract fans are corroded and are in the process of being repaired

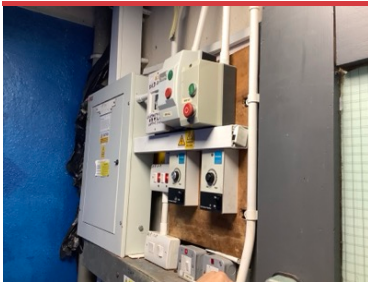
LEARNER POOL ELECTRICAL SERVICES DB

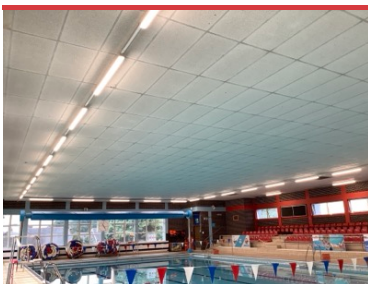
Small pool electrical system DB replaced a number of years ago, existing older wiring

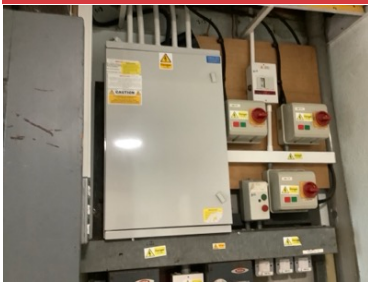
INDOOR POOL SERVICES AREA DB REPLACEMENT

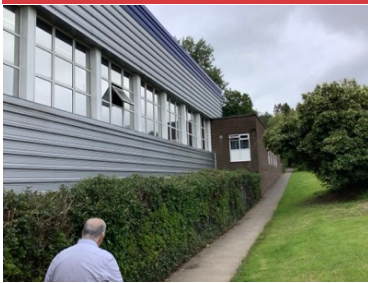
EXISTING CLADDING & INSULATION

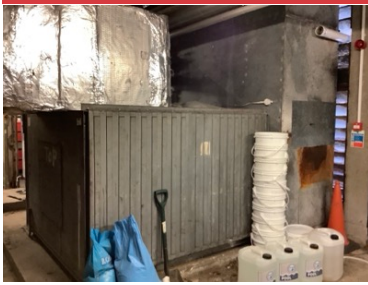
EXISTING AIR HANDLING UNIT

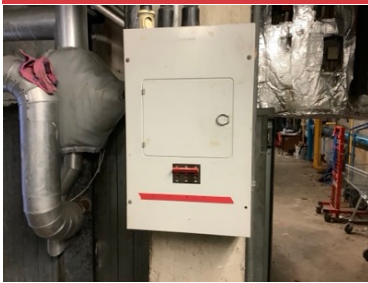
ISSUE 12 OLD DISTRIBUTION BOARDS

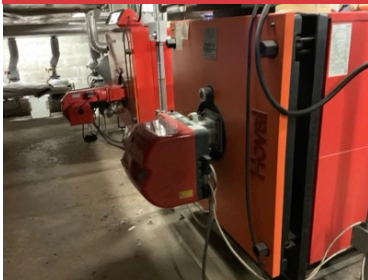
ISSUE 13 BOILER PLANT

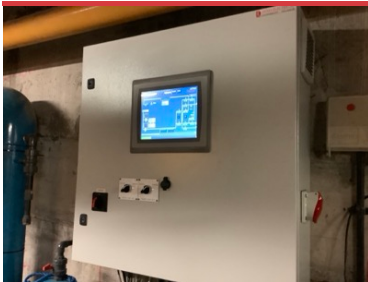
POOL FILTRATION SYSTEM

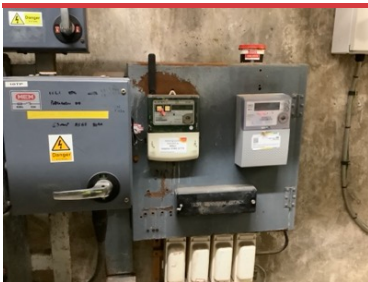
MAIN INCOMING SERVICE

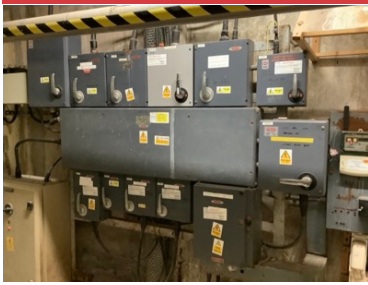
Badly corroded check load profile to see if electrical demand of property is with limits.
Refurbishment may require main supply cable upgrade to external transformer.

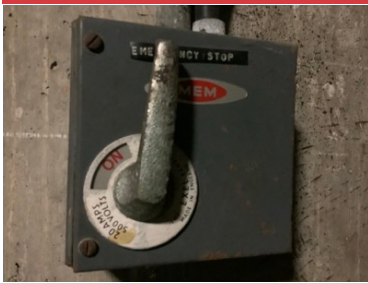
EMERGENCY STOP BUTTON FOR SMALL SUPPLY AHU

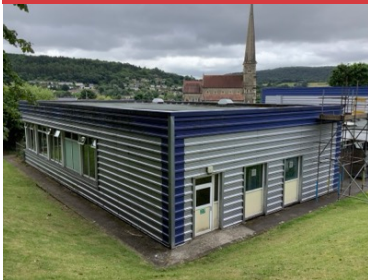
ROOF MOUNTED EXTRACT FANS

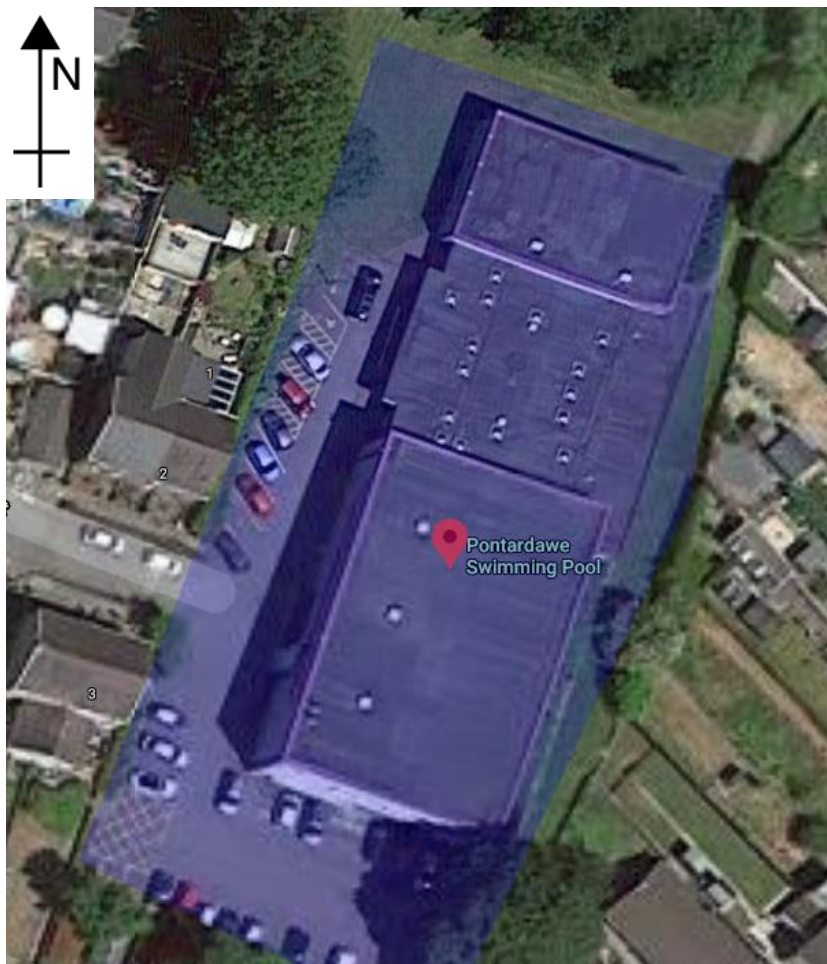
Figure 1 - Aerial view of Pontardawe Swimming Pool (Google maps image) with area reviewed highlighted in blue.

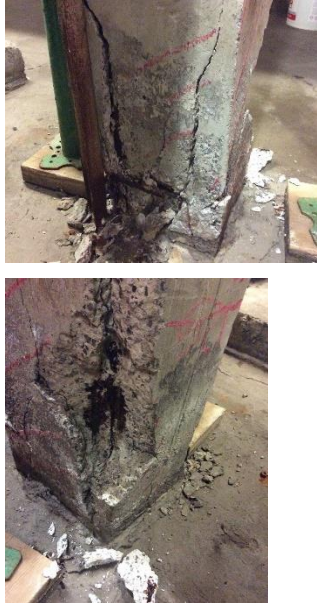
Reinforcement exposed to columns. Acro props been installed adjacent to worst affected columns. Concern over current capacity of props considering section loss of column.	Steel to be cleaned, painted and concrete repaired. Review prop requirement in interim.	D	1	July 2021

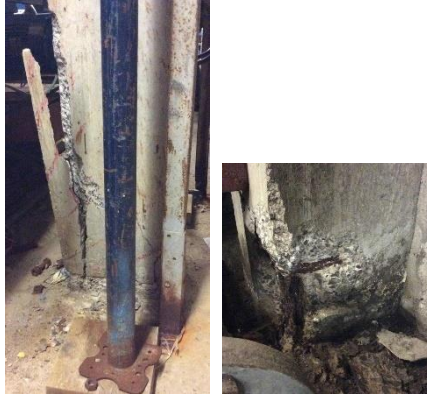
PS.02.	Staircase to basement

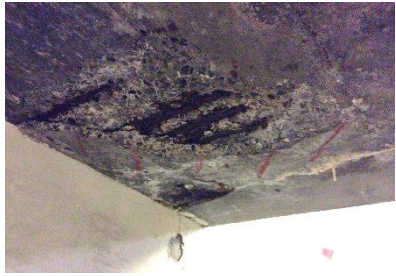
Concrete spalling and exposed reinforcement to soffit	Steel to be cleaned, painted and concrete repaired.	D	1	July 2021
PS.03.	Basement Plant Room

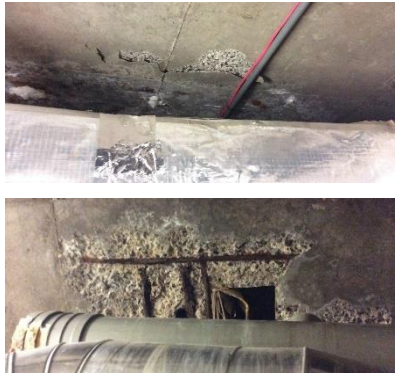
Concrete spalling and exposed reinforcement to soffit	Steel to be cleaned, painted and concrete repaired.	C	1	July 2021

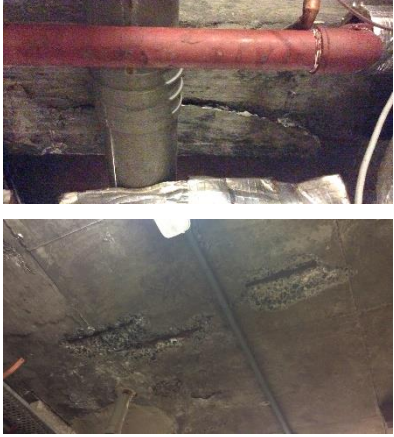
PS.04.	Basement Plant Room

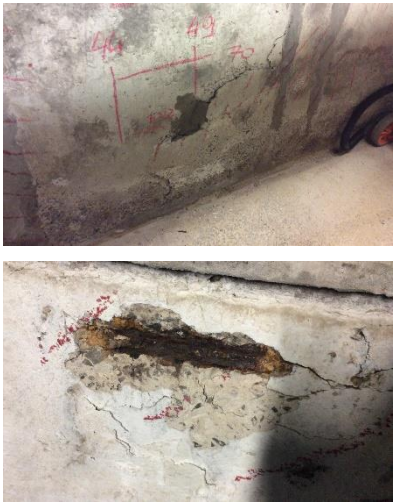
Damage to concrete (pool) walls, spalled concrete and some exposed reinforcement	loose concrete removed, reinforcement to be cleaned, painted and concrete repaired	C	2	April 2024

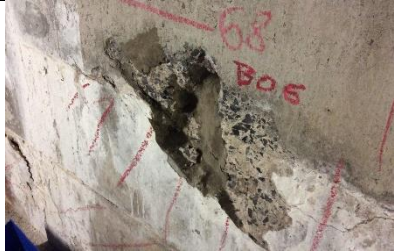
PS.05.	Basement Plant Room

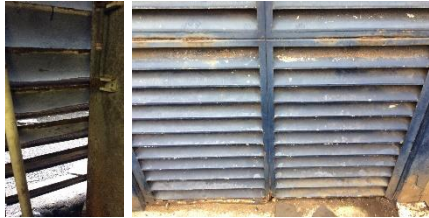
Steel louvres severely corroded.	To be cleaned and repainted or replaced	C	2	April 2024
PS.06.	Ground Floor Main Pool

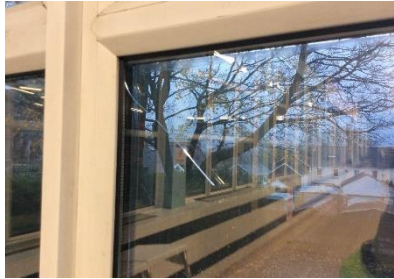
One Cracked pane. Likely thermal crack	IGU to be replaced	C	2	April 2024
PS.07.	Ground Floor Main Pool

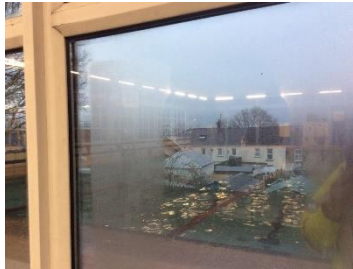
Couple of IGUs failed - interstitial condensation	IGU to be replaced	C	2	April 2024

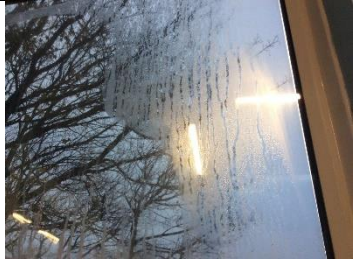
PS.08.	Ground Floor Store off Learner Pool

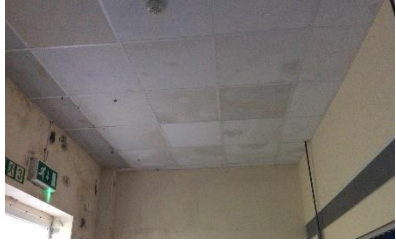
Ceiling tiles in poor condition.	Replace ceiling tiles	C	2	April 2024

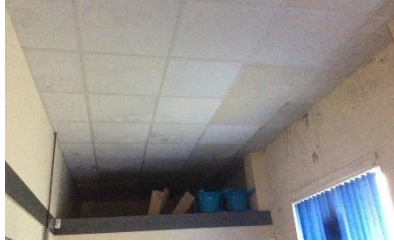
PS.010.	Ground Floor Store off Learner Pool

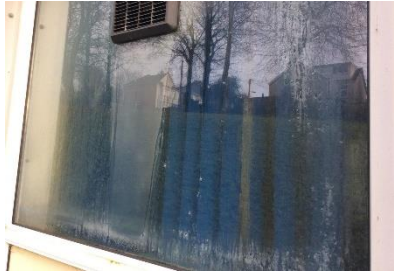
Glass units failed - interstitial condensation	IGUs to be replaced	C	2	April 2024
PS.011.	External External Wall

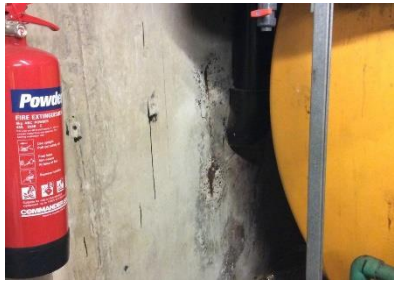
Exposed reinforcement to in-situ concrete walls	Steel to be cleaned, painted and concrete repaired.	B/C	2	April 2024

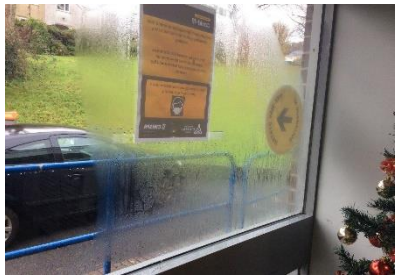
Lots condensation to windows in reception. Difficult to see if only surface or some interstitial	Review ventilation - check for interstitial condensation	B/C	3	End 2028
PS.013.	Ground Floor Main Pool

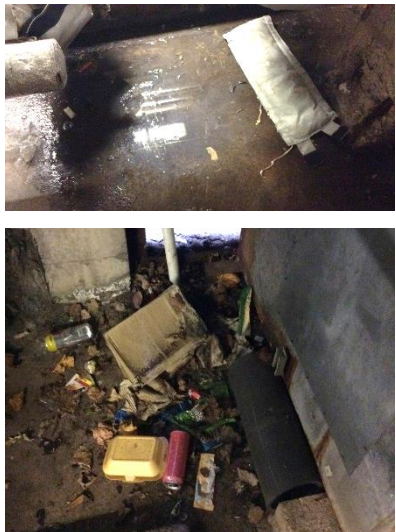
Pooling water, ruttid floor, dirty.	Floor to be cleaned, drained and repaired	B/C	3	End 2028

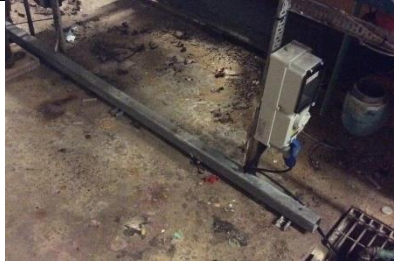
PS.015.	Ground Floor Main Reception

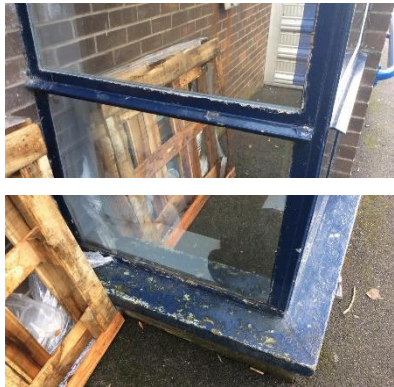
Painted steel single glazed units near main entrance in poor condition	Glass and frames to be replaced	B/C	3	End 2028

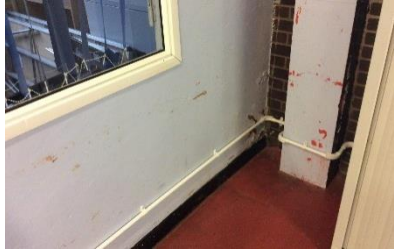
Paintwork blistering and flaking due to damp	Damp to be investigated and remediated. Re-decorate	B/C	3	End 2028
PS.018.	External External Area

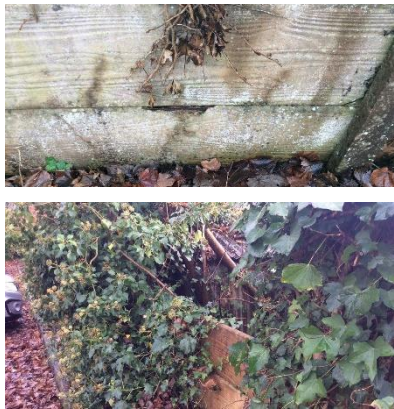
Concrete posts and planks car park boundary. Some spalling, some cracking, some missing, some poor alignment. Overgrown	Concrete planks to be replaced and concrete posts repaired. Vegetation to be cut back	B/C	3	End 2028
PS.019.	Ground Floor Main Pool

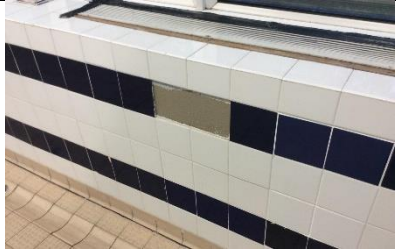
PS.020.	Ground Floor Main Pool

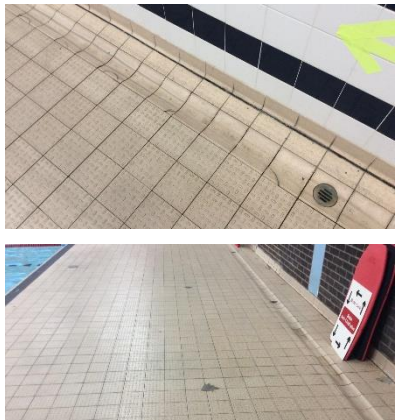
Multiple cracked tiles to floor	Tiles to be replaced	B/C	3	End 2028
PS.021.	Ground Floor Main Pool

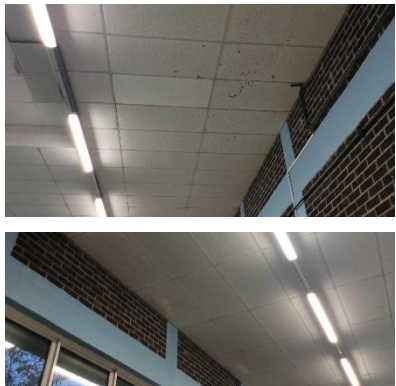
Ceiling to pool store and pool hall - tiles damaged, missing or stained	Ceiling tiles to be replaced	B/C	3	End 2028

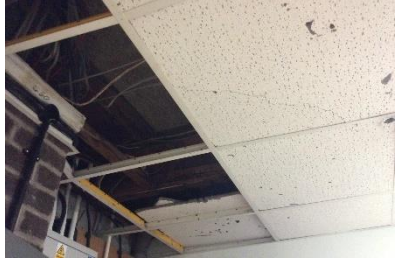
PS.022.	Ground Floor Learner Pool

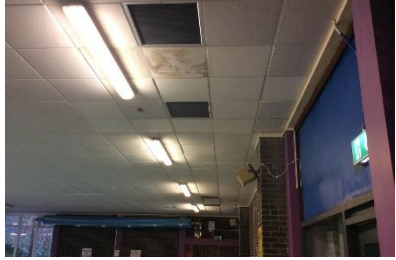
Ceiling tiles - Some uneven, some stained	Ceiling tiles to be replaced	B/C	3	End 2028
PS.023.	Ground Floor Changing Room (Female)

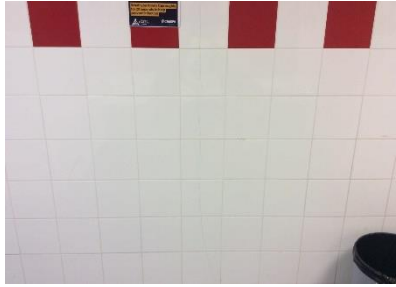
1 vertical crack apparent through wall tiles	Replace wall tiles	B/C	3	End 2028

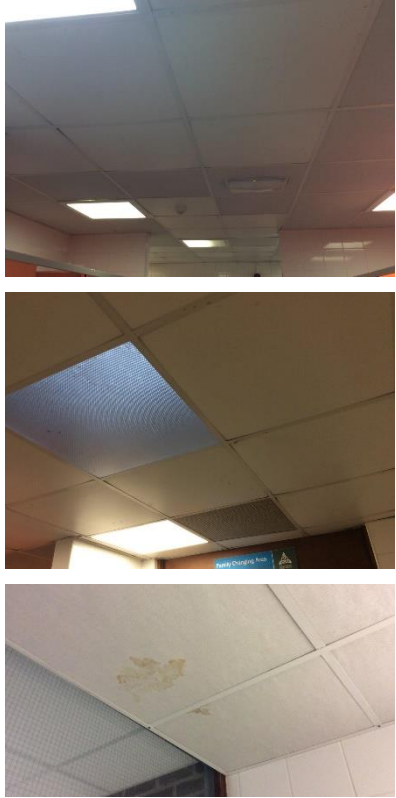
Ceiling tiles not matching and in various states of repair. Floor and walls typically OK	Ceiling tiles to be replaced	B/C	3	End 2028
PS.025.	Staircase to basement

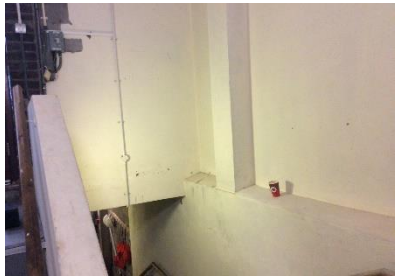
Paintwork scuffed and flaking in places	Walls to be redecorated	B/C	3	End 2028

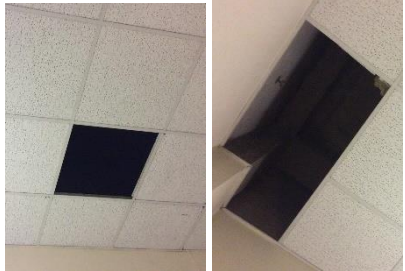
Ceiling tiles missing	Ceiling tiles to be replaced	B/C	3	End 2028

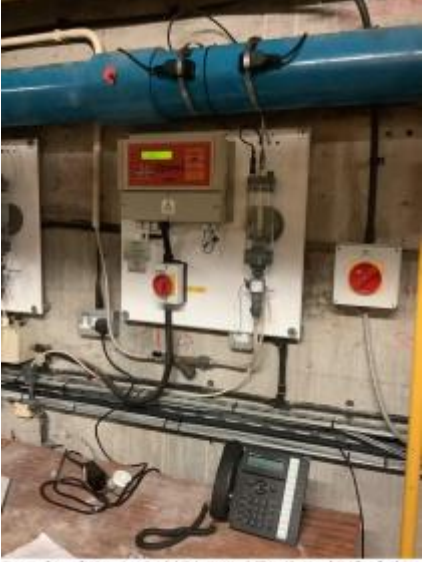
<p data-bbox="842 1167 1265 1182">Pontardawe Swimming Pool / Basement Plant Room / 5.13.1.3. / 1</p>

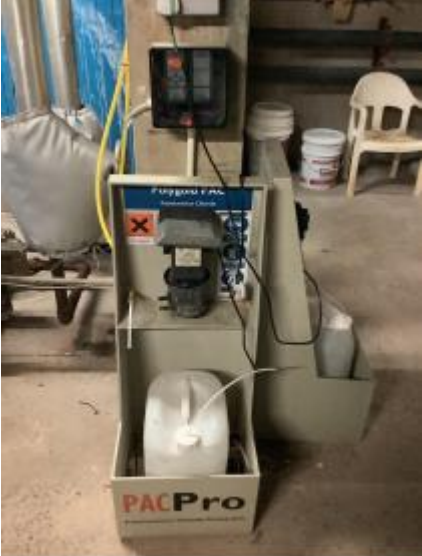
<p data-bbox="842 938 1265 958">Pontardawe Swimming Pool / Basement Plant Room / 5.13.1.3. / 1.</p>
<p>Location: Basement Plant Room</p> <p>Element Group/Code/Description: 5. Services / 5.13. Specialist Installations / 5.13.1. Specialist Piped Supply Installations / 5.13.1.3. Water Treatment</p> <p>Condition Grade: C</p> <p>Quantity/Unit: 1.00</p> <p>Cost: £3,300.00</p> <p>Comments: Poor condition</p> <p>Defects: End of Serviceable Life.</p> <p>Action: Replace</p>

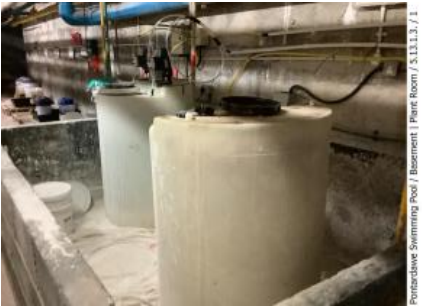
<p data-bbox="1249 1108 1265 1413" style="writing-mode: vertical-rl; transform: rotate(180deg);">Pontardawe Swimming Pool / Basement Plant Room / 5.13.1.3. / 1.</p>

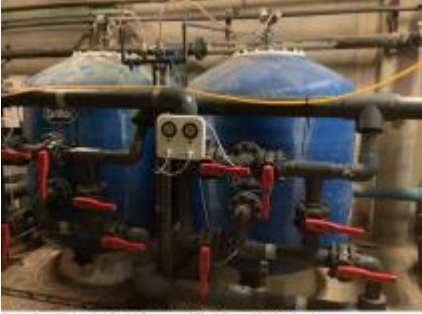
<p>Pontardawe Swimming Pool / Basement / Plant Room / 5.13.1.4. / 1</p>
<p>Location: Basement Plant Room</p> <p>Element Group/Code/Description: 5. Services / 5.13. Specialist Installations / 5.13.1. Specialist Piped Supply Installations / 5.13.1.4. Swimming Pool Treatment & Filtration</p> <p>Condition Grade: C</p> <p>Quantity/Unit: 1.00</p> <p>Cost: £4,500.00</p> <p>Comments: New membrane water treatment system for main pool</p> <p>Defects: No Defect.</p> <p>Action: Maintain</p>

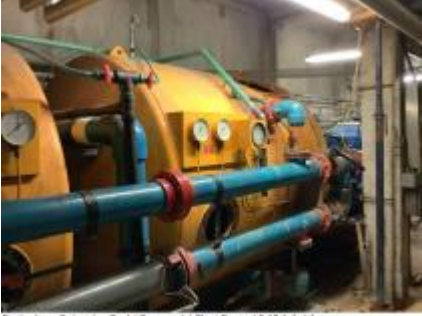
<p>Pontardawe Swimming Pool / Basement / Plant Room / 5.13.1.4. / 1</p>

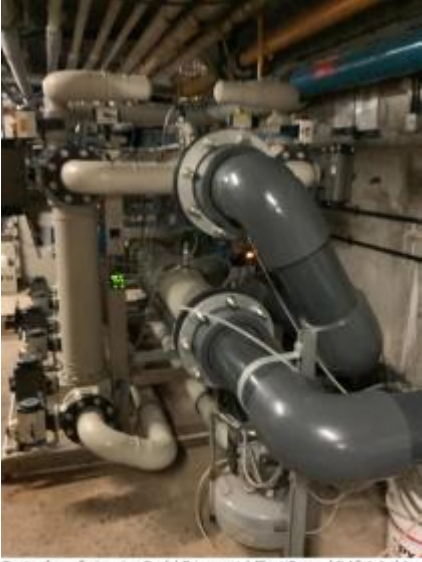
<p>Pontardawe Swimming Pool / Basement Plant Room / 5.13.1.4. / 1</p>
<p>Location: Basement Plant Room</p> <p>Element Group/Code/Description: 5. Services / 5.13. Specialist Installations / 5.13.1. Specialist Piped Supply Installations / 5.13.1.4. Swimming Pool Treatment & Filtration</p> <p>Condition Grade: C</p> <p>Quantity/Unit: 1.00</p> <p>Cost: £ 890.00</p> <p>Comments: New control panel for water treatment system installed approx 5 years ago</p> <p>Defects: No Defect.</p> <p>Action: Maintain</p>

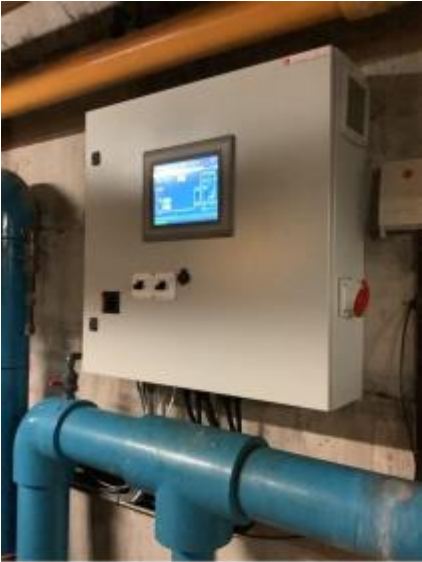
<p>Pontardawe Swimming Pool / Basement Plant Room / 5.13.1.4. / 1</p>

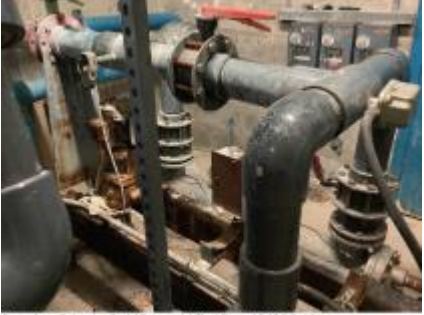
<p style="font-size: small; text-align: center;">Pontardawe Swimming Pool / Basement Plant Room / 5.13.5.2. / 1</p>
<p>Location: Basement Plant Room</p> <p>Element Group/Code/Description: 5. Services / 5.13. Specialist Installations / 5.13.5. Water Features / 5.13.5.2. Pumps, Filtration Equipment Etc.</p> <p>Condition Grade: A</p> <p>Quantity/Unit: 0.00</p> <p>Cost: £1,850.00</p> <p>Comments: Newly installed</p> <p>Defects: No Defect.</p> <p>Action: Maintain</p>

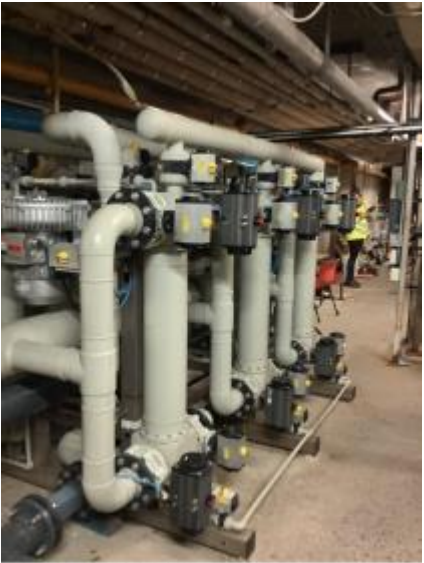
<p style="font-size: small; text-align: center;">Pontardawe Swimming Pool / Basement Plant Room / 5.13.5.2. / 1</p>

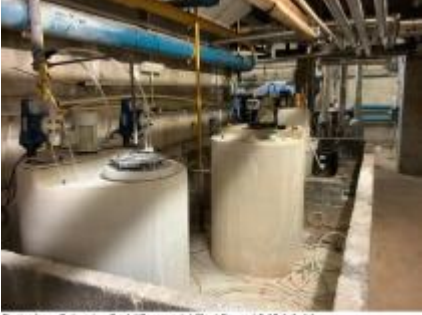
<p style="font-size: small; text-align: center;">Pontardawe Swimming Pool / Basement Plant Room / 5.13.1.4. / 1</p>
<p>Location: Basement Plant Room</p> <p>Element Group/Code/Description: 5. Services / 5.13. Specialist Installations / 5.13.5. Water Features / 5.13.5.2. Pumps, Filtration Equipment Etc.</p> <p>Condition Grade: C</p> <p>Quantity/Unit: 0.00</p> <p>Cost: £1,930.00</p> <p>Comments: Poor condition</p> <p>Defects: End of Serviceable Life.</p> <p>Action: Replace</p>

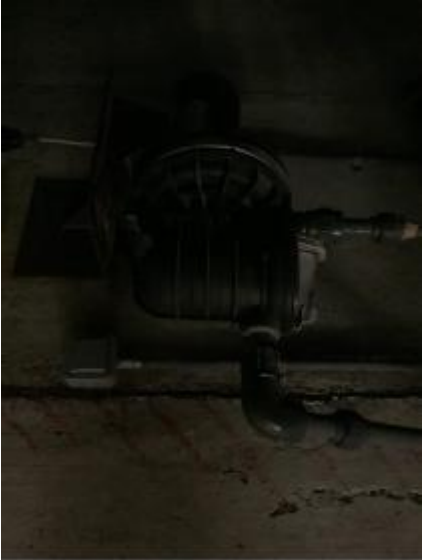
<p style="font-size: small; text-align: center;">Pontardawe Swimming Pool / Basement Plant Room / 5.13.5.2. / 1</p>

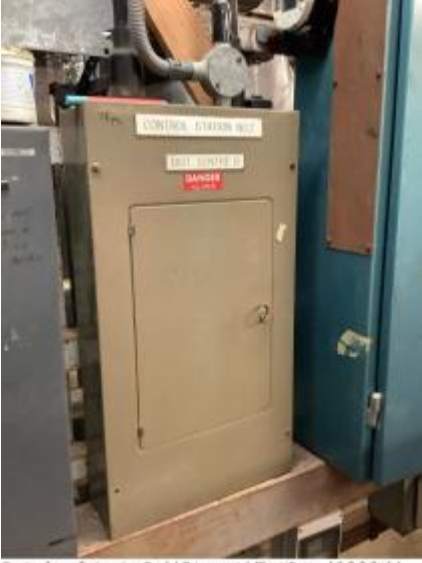
<p>Portardawe Swimming Pool / Basement Plant Room / 5.8.2.2. / 1</p>
<p>Location: Basement Plant Room</p> <p>Element Group/Code/Description: 5. Services / 5.5. Heat Source / 5.5.1. Heat Source / 5.5.1.10. Flues – Common</p> <p>Condition Grade: C</p> <p>Quantity/Unit: 2.00</p> <p>Cost: £3,500.00</p> <p>Comments: Part of original, installation</p> <p>Defects: .</p> <p>Action: Replace</p>

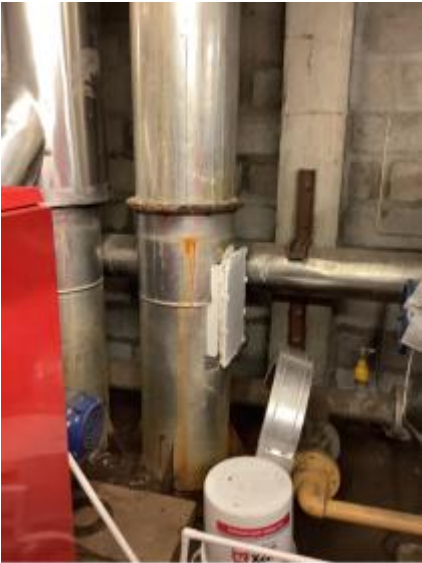
<p>Portardawe Swimming Pool / Basement Plant Room / 5.5.1.10. / 1</p>

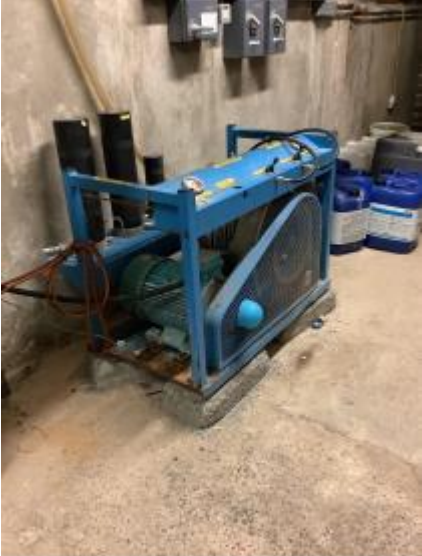
<p>Pontardawe Swimming Pool / Basement Plant Room / 5.13.5.3. / 1</p>
<p>Location: Basement Plant Room</p> <p>Element Group/Code/Description: 5. Services / 5.8 . Electrical Installations / 5.8.2. Power Installations / 5.8.2.3. Sub-Switchboard</p> <p>Condition Grade: C</p> <p>Quantity/Unit: 1.00</p> <p>Cost: £ 996.00</p> <p>Comments: Refurbish</p> <p>Defects: End of Serviceable Life.</p> <p>Action: Replace</p>

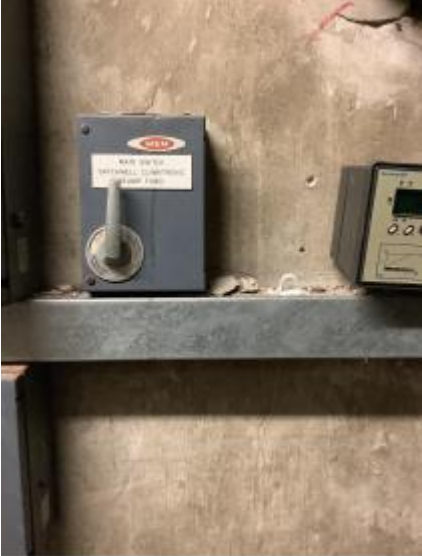
<p>Pontardawe Swimming Pool / Basement Plant Room / 5.8.2.3. / 1</p>

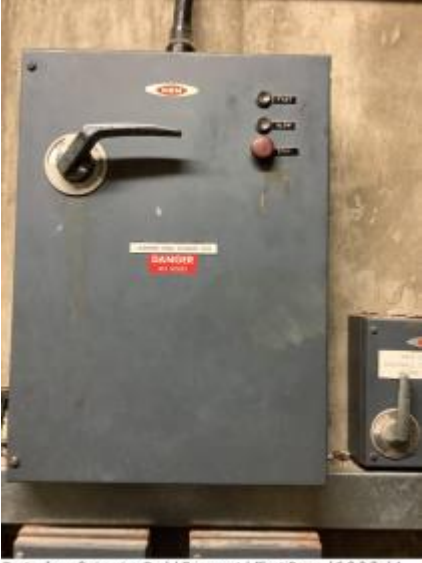
<p>Pontardawe Swimming Pool / Basement Plant Room / 5.8.2.3. / 1</p>
<p>Location: Basement Plant Room</p> <p>Element Group/Code/Description: 5. Services / 5.8 . Electrical Installations / 5.8.2. Power Installations / 5.8.2.3. Sub-Switchboard</p> <p>Condition Grade: C</p> <p>Quantity/Unit: 1.00</p> <p>Cost: £ 996.00</p> <p>Comments: Refurbish</p> <p>Defects: End of Serviceable Life.</p> <p>Action: Replace</p>

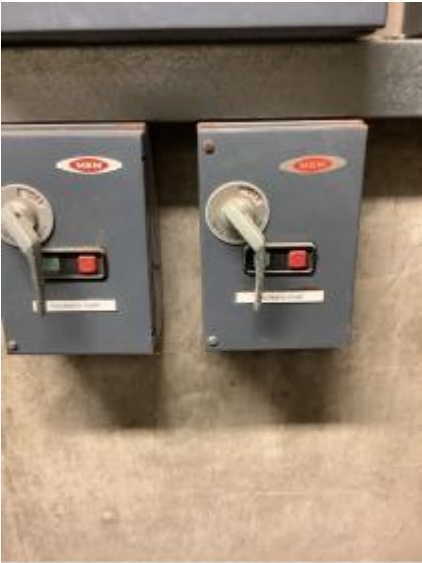
<p>Pontardawe Swimming Pool / Basement Plant Room / 5.8.2.3. / 1</p>

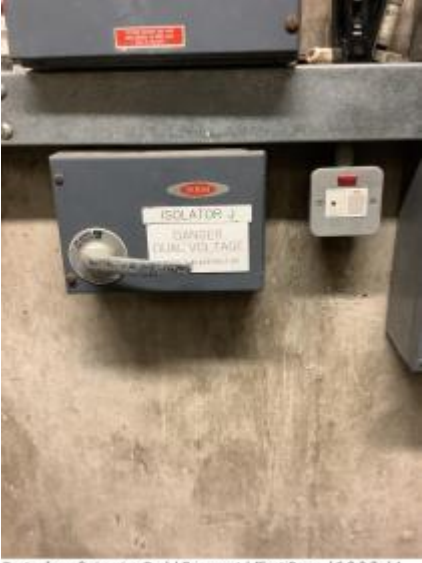
<p>Pontardawe Swimming Pool / Basement Plant Room / 5.8.2.3. / 1</p>
<p>Location: Basement Plant Room</p> <p>Element Group/Code/Description: 5. Services / 5.8 . Electrical Installations / 5.8.1. Electric Mains & Sub-Mains Distribution / 5.8.1.10. Main Switchboard</p> <p>Condition Grade: C</p> <p>Quantity/Unit: 0.00</p> <p>Cost: £8,540.00</p> <p>Comments: Bus bar s replace with new MCCB switch panel</p> <p>Defects: End of Serviceable Life.</p> <p>Action: Replace</p>

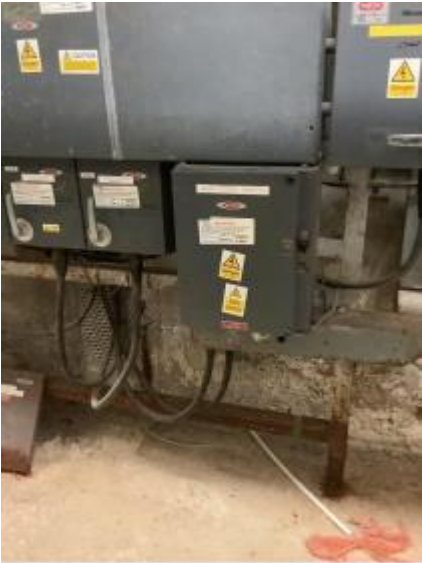
<p>Pontardawe Swimming Pool / Basement Plant Room / 5.8.1.10. / 1</p>

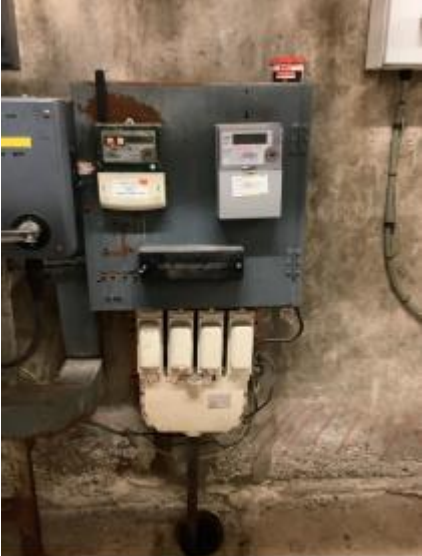
<p data-bbox="842 938 1265 958">Pontardawe Swimming Pool / Basement Plant Room / 5.8.1.1. / 1</p>
<p>Location: Basement Plant Room</p> <p>Element Group/Code/Description: 5. Services / 5.8 . Electrical Installations / 5.8.1. Electric Mains & Sub-Mains Distribution / 5.8.1.9. Power Factor Correction</p> <p>Condition Grade: C</p> <p>Quantity/Unit: 1.00</p> <p>Cost: £2,500.00</p> <p>Comments: Refurbish</p> <p>Defects: End of Serviceable Life.</p> <p>Action: Replace</p>

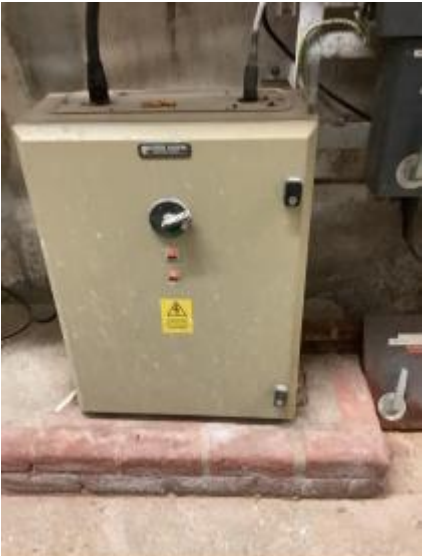
<p data-bbox="842 1700 1265 1720">Pontardawe Swimming Pool / Basement Plant Room / 5.8.1.9. / 1</p>

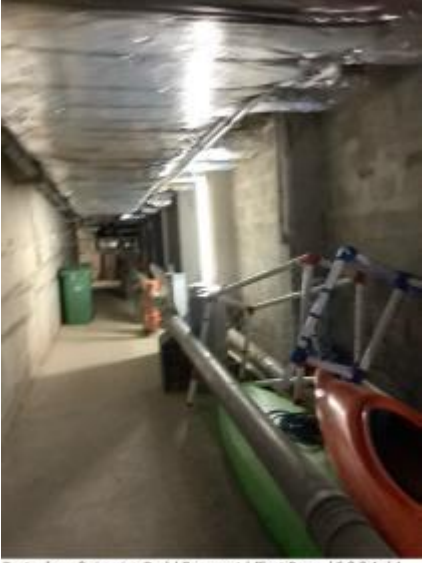
<p data-bbox="842 943 1265 965">Pontardawe Swimming Pool / Basement Plant Room / 5.8.3.4. / 1</p>
<p>Location: Basement Plant Room</p> <p>Element Group/Code/Description: 5. Services / 5.8 . Electrical Installations / 5.8.2. Power Installations / 5.8.2.3. Sub-Switchboard</p> <p>Condition Grade: C</p> <p>Quantity/Unit: 1.00</p> <p>Cost: £ 996.00</p> <p>Comments: Refurbish</p> <p>Defects: End of Serviceable Life.</p> <p>Action: Replace</p>

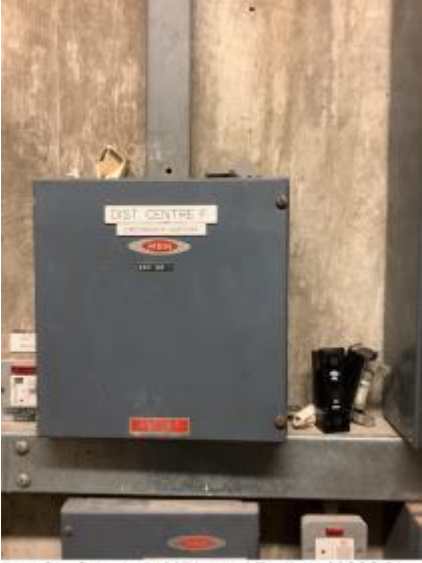
<p data-bbox="842 1671 1265 1693">Pontardawe Swimming Pool / Basement Plant Room / 5.8.2.3. / 1</p>

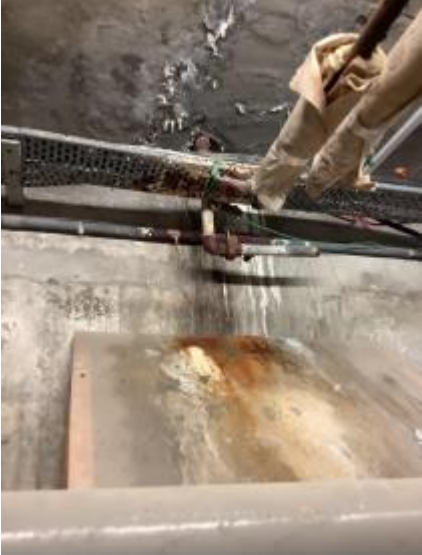
<p>Pontardawe Swimming Pool / Basement Plant Room / 5.8.2.7. / 1</p>
<p>Location: Basement Plant Room</p> <p>Element Group/Code/Description: 5. Services / 5.8 . Electrical Installations / 5.8.2. Power Installations / 5.8.2.3. Sub-Switchboard</p> <p>Condition Grade: C</p> <p>Quantity/Unit: 1.00</p> <p>Cost: £1,285.00</p> <p>Comments: Refurbish</p> <p>Defects: End of Serviceable Life.</p> <p>Action: Replace</p>

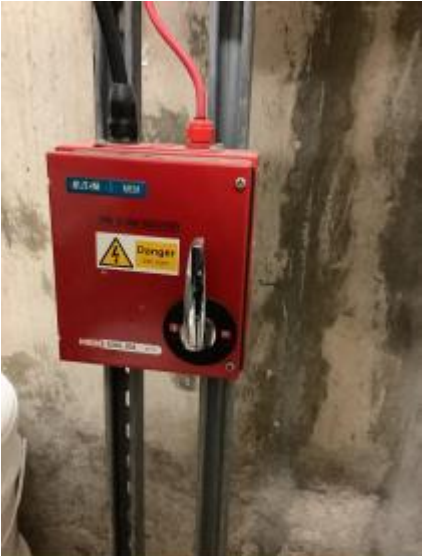
<p>Pontardawe Swimming Pool / Basement Plant Room / 5.8.2.3. / 1</p>

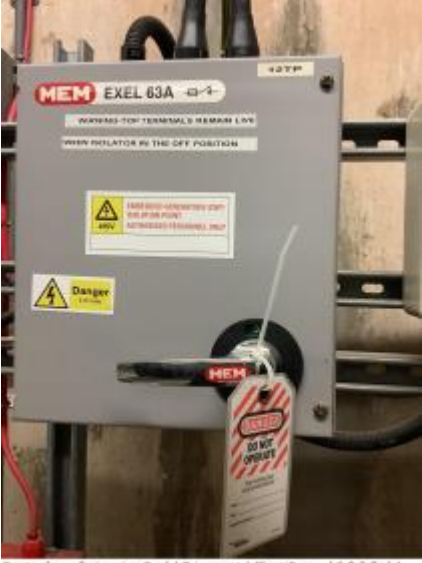
<p>Pontardawe Swimming Pool / Basement Plant Room / 5.8.2.3. / 1</p>
<p>Location: Basement Plant Room</p> <p>Element Group/Code/Description: 5. Services / 5.8 . Electrical Installations / 5.8.2. Power Installations / 5.8.2.3. Sub-Switchboard</p> <p>Condition Grade: C</p> <p>Quantity/Unit: 1.00</p> <p>Cost: £ 996.00</p> <p>Comments: Refurbish</p> <p>Defects: End of Serviceable Life.</p> <p>Action: Replace</p>

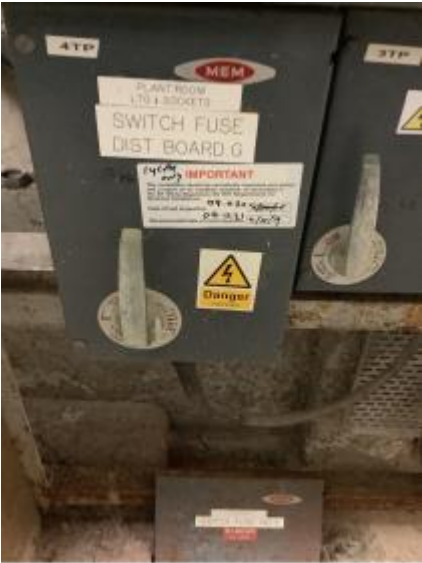
<p>Pontardawe Swimming Pool / Basement Plant Room / 5.8.2.3. / 1</p>
