**Neath Port Talbot County Borough Council
Cyngor Bwrdeistref Sirol Castell-nedd**

**Democratic Services
Gwasanaethau Democrataidd**

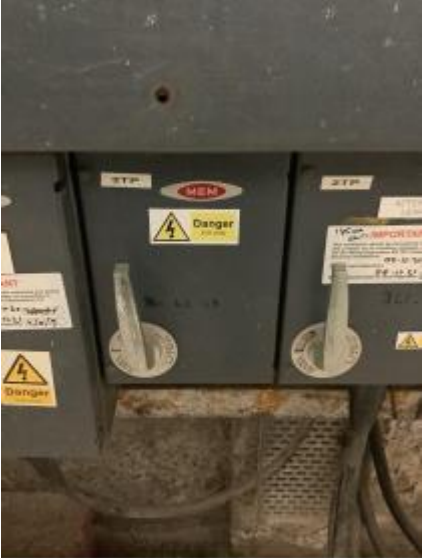
<p data-bbox="842 1666 1265 1686">Pontardawe Swimming Pool / Basement Plant Room / 5.8.2.3. / 1</p>

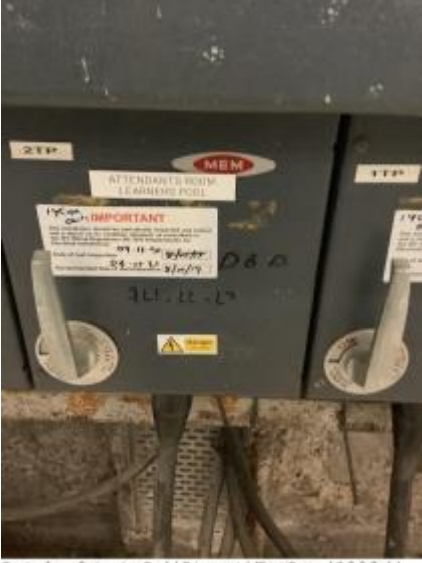
<p>Pontardawe Swimming Pool / Basement Plant Room / 5.8.2.3. / 1</p>
<p>Location: Basement Plant Room</p> <p>Element Group/Code/Description: 5. Services / 5.8 . Electrical Installations / 5.8.2. Power Installations / 5.8.2.3. Sub-Switchboard</p> <p>Condition Grade: C</p> <p>Quantity/Unit: 1.00</p> <p>Cost: £1,285.00</p> <p>Comments: Refurbish</p> <p>Defects: End of Serviceable Life.</p> <p>Action: Replace</p>

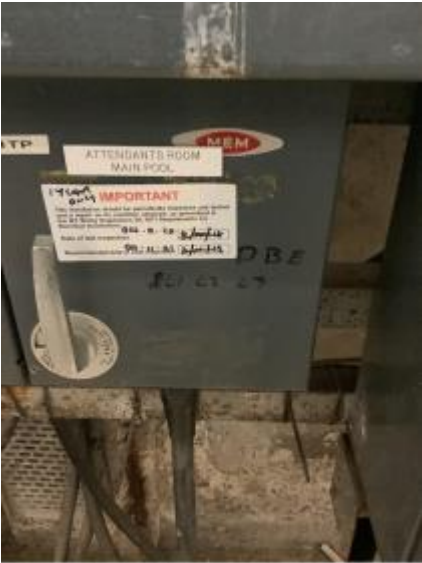
<p>Pontardawe Swimming Pool / Basement Plant Room / 5.8.2.3. / 1</p>

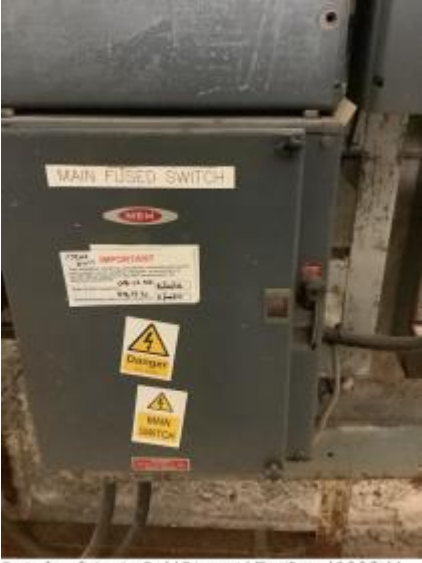
<p>Pontardawe Swimming Pool / Basement Plant Room / 5.8.2.3. / 1</p>
<p>Location: Basement Plant Room</p> <p>Element Group/Code/Description: 5. Services / 5.8 . Electrical Installations / 5.8.2. Power Installations / 5.8.2.3. Sub-Switchboard</p> <p>Condition Grade: C</p> <p>Quantity/Unit: 1.00</p> <p>Cost: £1,285.00</p> <p>Comments: Refurbish</p> <p>Defects: End of Serviceable Life.</p> <p>Action: Replace</p>

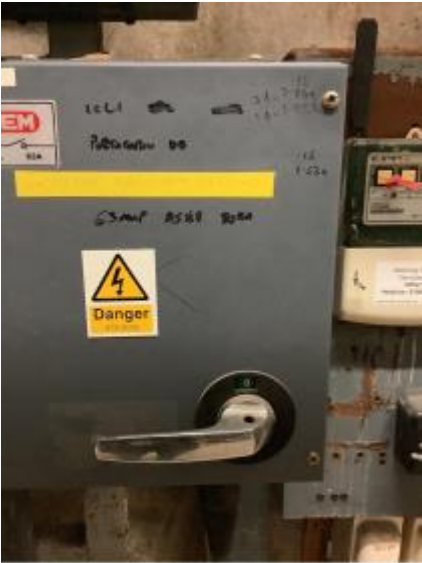
<p>Pontardawe Swimming Pool / Basement Plant Room / 5.8.2.3. / 1</p>

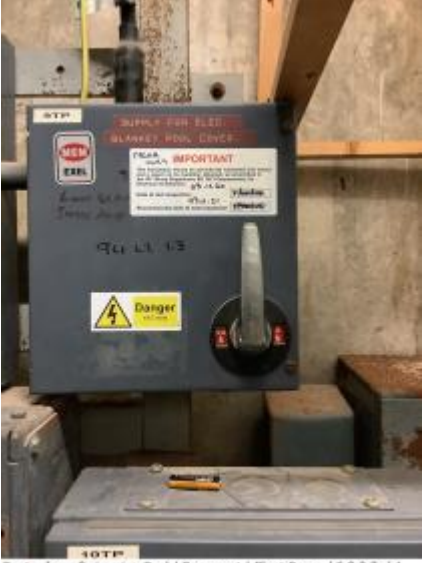
<p>Pontardawe Swimming Pool / Basement Plant Room / 5.8.2.3. / 1</p>
<p>Location: Basement Plant Room</p> <p>Element Group/Code/Description: 5. Services / 5.8 . Electrical Installations / 5.8.2. Power Installations / 5.8.2.3. Sub-Switchboard</p> <p>Condition Grade: C</p> <p>Quantity/Unit: 0.00</p> <p>Cost: £1,285.00</p> <p>Comments: Refurbish</p> <p>Defects: End of Serviceable Life.</p> <p>Action: Replace</p>

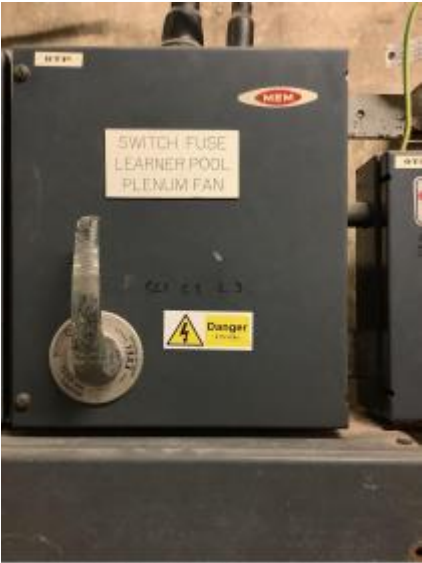
<p>Pontardawe Swimming Pool / Basement Plant Room / 5.8.2.3. / 1</p>

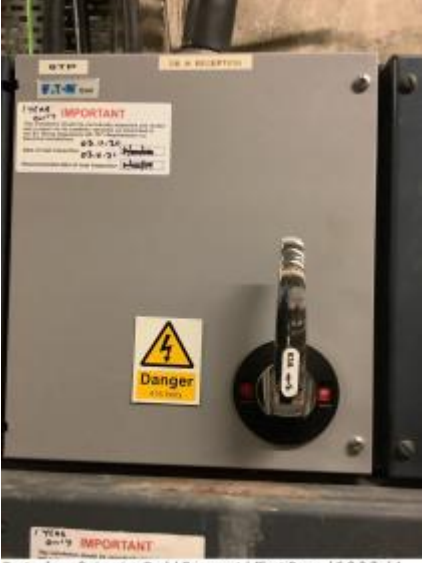
<p>Pontardawe Swimming Pool / Basement Plant Room / 5.8.2.3. / 1</p>
<p>Location: Basement Plant Room</p> <p>Element Group/Code/Description: 5. Services / 5.8 . Electrical Installations / 5.8.2. Power Installations / 5.8.2.3. Sub-Switchboard</p> <p>Condition Grade: C</p> <p>Quantity/Unit: 1.00</p> <p>Cost: £ 597.93</p> <p>Comments: Refurbishment electrical installation</p> <p>Defects: End of Serviceable Life.</p> <p>Action: Replace</p>

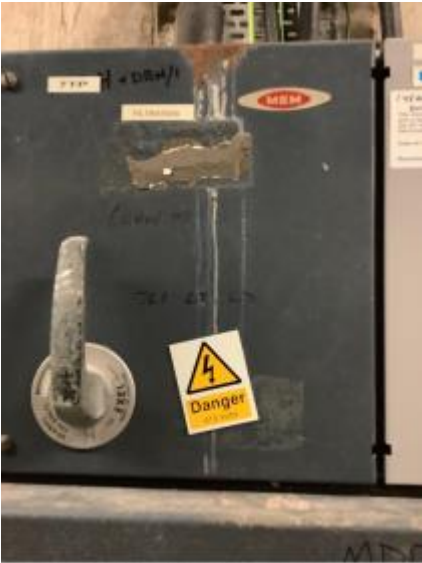
<p>Pontardawe Swimming Pool / Basement Plant Room / 5.8.2.3. / 1</p>

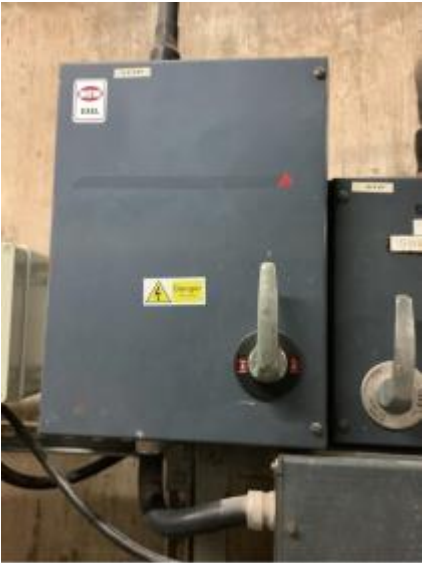
<p style="font-size: small;">Pontardawe Swimming Pool / Basement Plant Room / 5.8.2.3. / 1</p>

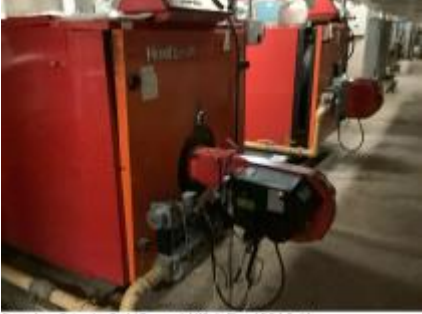
<p data-bbox="842 696 1265 707">Pontardawe Swimming Pool / Basement Whole Floor / 5.5.1.6. / 1</p>
<p>Location: Basement Whole Floor</p> <p>Element Group/Code/Description: 5. Services / 5.8. Electrical Installations / 5.8.3. Lighting Installations / 5.8.3.6. Luminaires</p> <p>Condition Grade: C</p> <p>Quantity/Unit: 4.00</p> <p>Cost: £ 290.00</p> <p>Comments: Replace with LED</p> <p>Defects: End of Serviceable Life.</p> <p>Action: Replace</p>

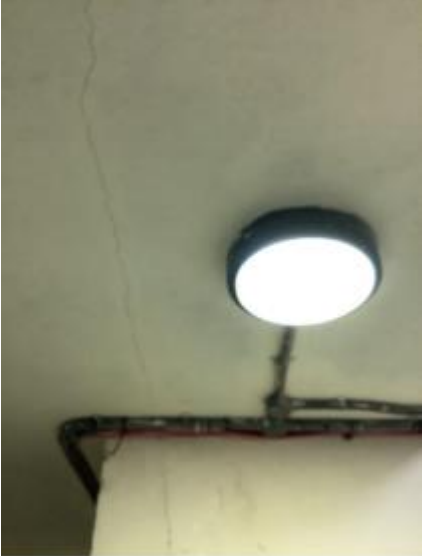
<p data-bbox="842 1630 1265 1641">Pontardawe Swimming Pool / Basement Whole Floor / 5.8.3.6. / 1</p>

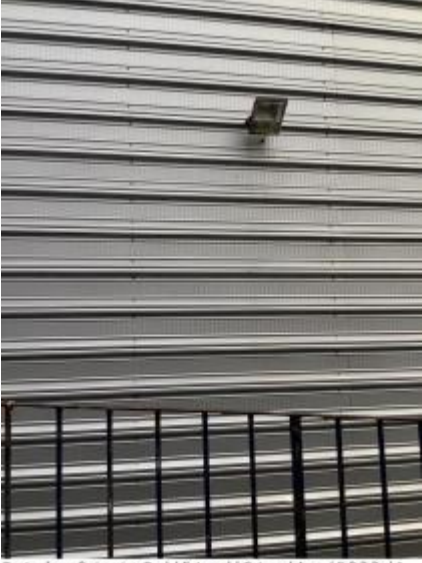
<p data-bbox="842 943 1265 958">Pontardawe Swimming Pool / External External Area / 5.8.3.2. / 1</p>
<p>Location: External External Area</p> <p>Element Group/Code/Description: 5. Services / 5.8 . Electrical Installations / 5.8.3. Lighting Installations / 5.8.3.2. External Luminaires</p> <p>Condition Grade: C</p> <p>Quantity/Unit: 4.00</p> <p>Cost: £ 450.00</p> <p>Comments: Replace with LED lighting</p> <p>Defects: End of Serviceable Life.</p> <p>Action: Replace</p>

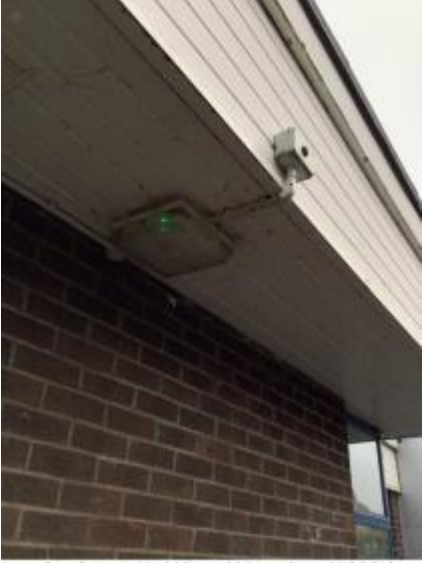
<p data-bbox="842 1671 1265 1686">Pontardawe Swimming Pool / External External Area / 5.8.3.2. / 1</p>

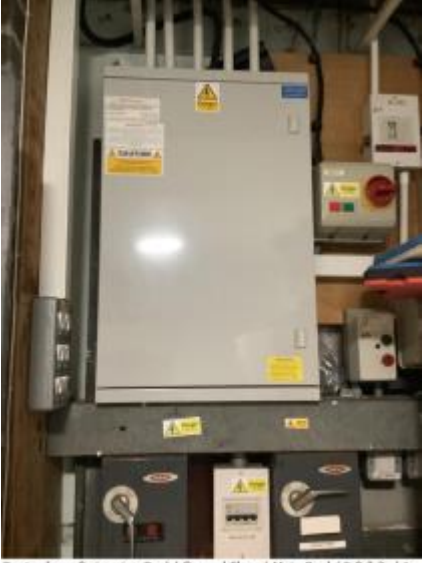
<p>Pontardawe Swimming Pool / Ground Floor Main Pool / 5.8.2.2. / 1.</p>
<p>Location: Ground Floor Main Pool</p> <p>Element Group/Code/Description: 5. Services / 5.7. Ventilation Systems / 5.7.2. Local & Special Ventilation / 5.7.2.4. Fan - Single</p> <p>Condition Grade: C</p> <p>Quantity/Unit: 1.00</p> <p>Cost: £ 462.00</p> <p>Comments: Run to failure</p> <p>Defects: End of Serviceable Life.</p> <p>Action: Replace</p>

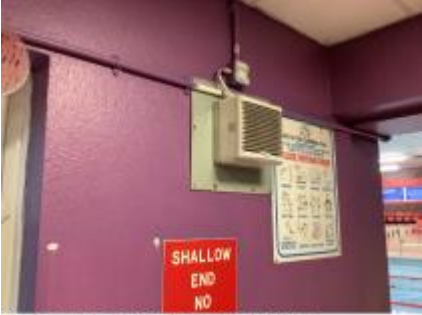
<p>Pontardawe Swimming Pool / Ground Floor Main Pool / 5.7.2.4. / 1.</p>

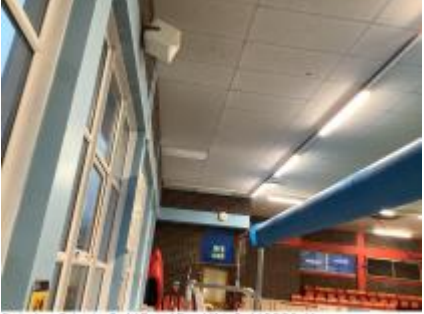
<p>Pontardawe Swimming Pool / Ground Floor Main Pool / 5.8.3.6. / 1</p>
<p>Location: Ground Floor Main Pool</p> <p>Element Group/Code/Description: 5. Services / 5.6. Space Heating & Air Conditioning / 5.6.1. Central Heating / 5.6.1.16. Fan Convectors</p> <p>Condition Grade: C</p> <p>Quantity/Unit: 13.00</p> <p>Cost: £2,470.00</p> <p>Comments: Replace or Refurbish</p> <p>Defects: End of Serviceable Life.</p> <p>Action: Replace</p>

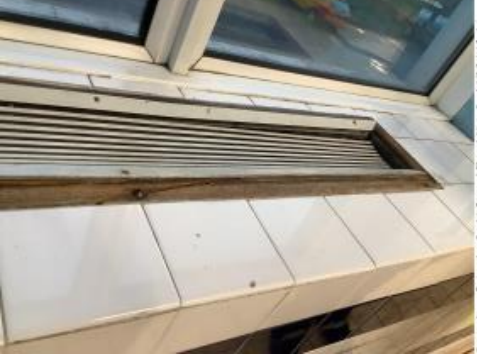
<p>Pontardawe Swimming Pool / Ground Floor Main Pool / 5.6.1.16. / 1</p>

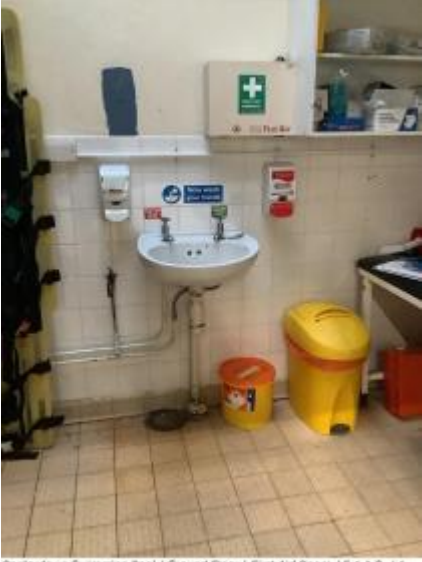
<p>Pontardawe Swimming Pool / Ground Floor First Aid Room / 5.1.1.9. / 1</p>
<p>Location: Ground Floor Creche</p> <p>Element Group/Code/Description: 5. Services / 5.7. Ventilation Systems / 5.7.2. Local & Special Ventilation / 5.7.2.4. Fan - Single</p> <p>Condition Grade: C</p> <p>Quantity/Unit: 2.00</p> <p>Cost: £ 240.00</p> <p>Comments: Appears redundant remove and make good</p> <p>Defects: Obsolete.</p> <p>Action: Replace</p>

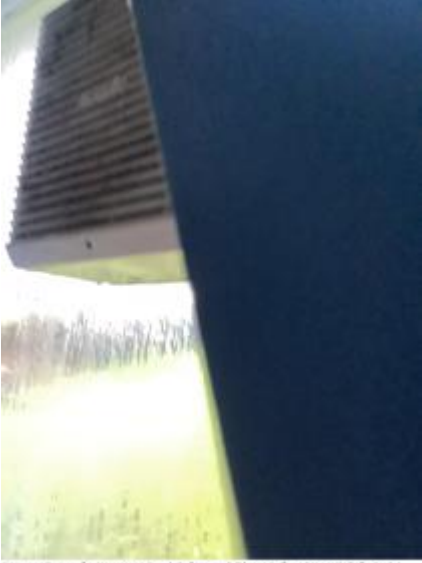
<p>Pontardawe Swimming Pool / Ground Floor Creche / 5.7.2.4. / 1</p>

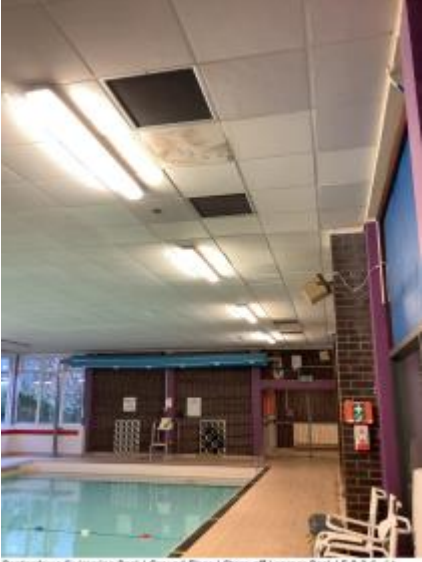
<p data-bbox="842 943 1265 958">Pontardawe Swimming Pool / Ground Floor Store off Learner Pool / 5.8.3.6. / 1</p>
<p>Location: Ground Floor Store off Main Pool</p> <p>Element Group/Code/Description: 5. Services / 5.8 . Electrical Installations / 5.8.2. Power Installations / 5.8.2.2. Distribution Boards</p> <p>Condition Grade: C</p> <p>Quantity/Unit: 1.00</p> <p>Cost: £1,350.00</p> <p>Comments: Maintain upgrading in line with recommendations from inspections reports</p> <p>Defects: End of Serviceable Life.</p> <p>Action: Replace</p>

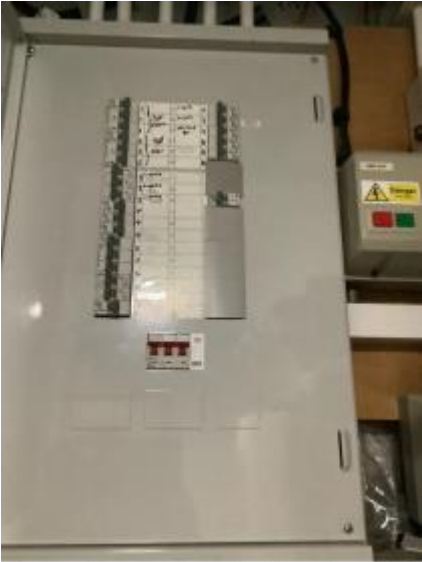
<p data-bbox="842 1704 1265 1720">Pontardawe Swimming Pool / Ground Floor Store off Main Pool / 5.8.2.2. / 1</p>

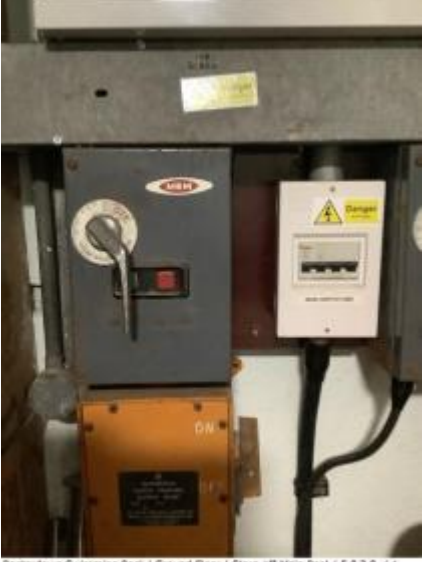
<p data-bbox="842 943 1265 958">Pontardawe Swimming Pool / Ground Floor Store off Main Pool / 5.8.2.8. / 1</p>
<p>Location: Ground Floor Changing Room (Male)</p> <p>Element Group/Code/Description: 5. Services / 5.1. Sanitary Installations / 5.1.1. Sanitary Appliances / 5.1.1.6. Shower Tray</p> <p>Condition Grade: C</p> <p>Quantity/Unit: 1.00</p> <p>Cost: £ 350.00</p> <p>Comments: Service and replace units as they fail</p> <p>Defects: Fair Condition.</p> <p>Action: Replace</p>

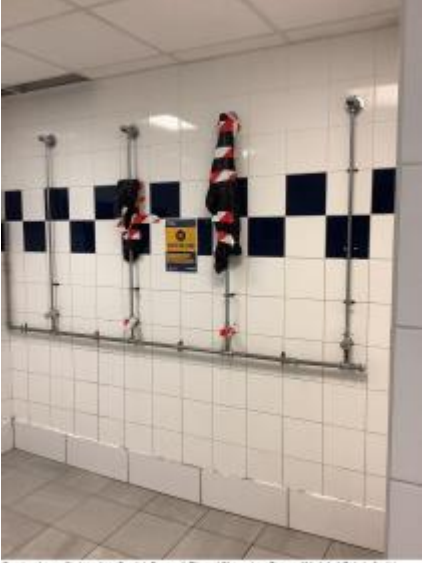
<p data-bbox="842 1706 1265 1722">Pontardawe Swimming Pool / Ground Floor Changing Room (Male) / 5.1.1.6. / 1</p>

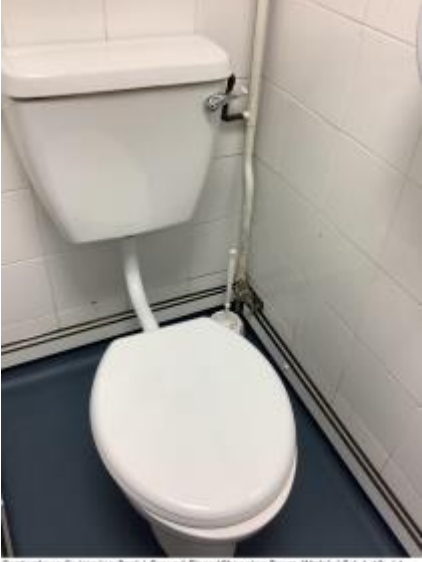
<p>Location: Ground Floor Changing Room (Male)</p> <p>Element Group/Code/Description: 5. Services / 5.1. Sanitary Installations / 5.1.1. Sanitary Appliances / 5.1.1.9. Wash Hand Basin and Taps</p> <p>Condition Grade: C</p> <p>Quantity/Unit: 2.00</p> <p>Cost: £ 350.00</p> <p>Comments: Maintain and repair as and when required</p> <p>Defects: Fair Condition.</p> <p>Action: Maintain</p>

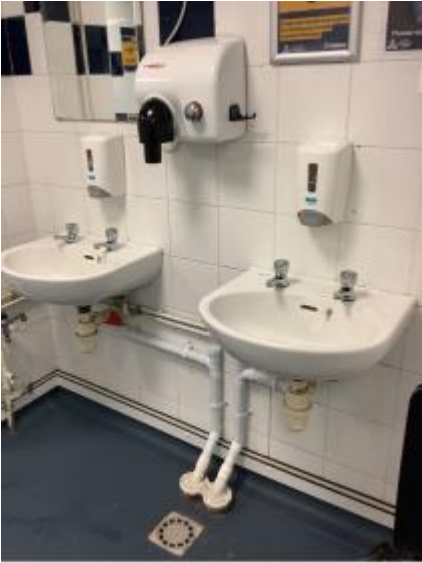
Details	Photo
<p>Location: Ground Floor Changing Room (Male)</p> <p>Element Group/Code/Description: 5. Services / 5.1. Sanitary Installations / 5.1.1. Sanitary Appliances / 5.1.1.8. Urinals (Bowl)</p> <p>Condition Grade: C</p> <p>Quantity/Unit: 2.00</p> <p>Cost: £ 450.00</p> <p>Comments: Maintain answer service</p> <p>Defects: Fair Condition.</p> <p>Action: Maintain</p>

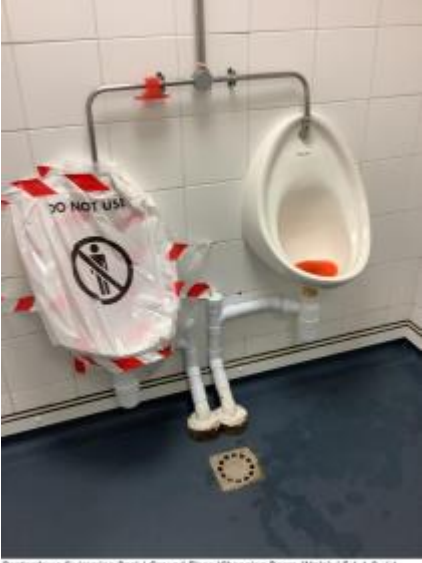
<p>Pontardawe Swimming Pool / Ground Floor Changing Room (Male) / 5.1.1.8. / 1</p>
<p>Location: Ground Floor Changing Room (Male)</p> <p>Element Group/Code/Description: 5. Services / 5.1. Sanitary Installations / 5.1.1. Sanitary Appliances / 5.1.1.4. Cisterniser and Water Saver</p> <p>Condition Grade: C</p> <p>Quantity/Unit: 1.00</p> <p>Cost: £ 369.00</p> <p>Comments: Run to failure</p> <p>Defects: Fair Condition.</p> <p>Action: Replace</p>

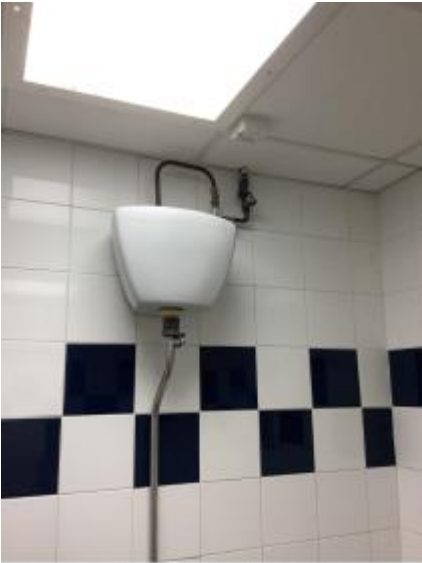
<p>Pontardawe Swimming Pool / Ground Floor Changing Room (Male) / 5.1.1.4. / 1</p>

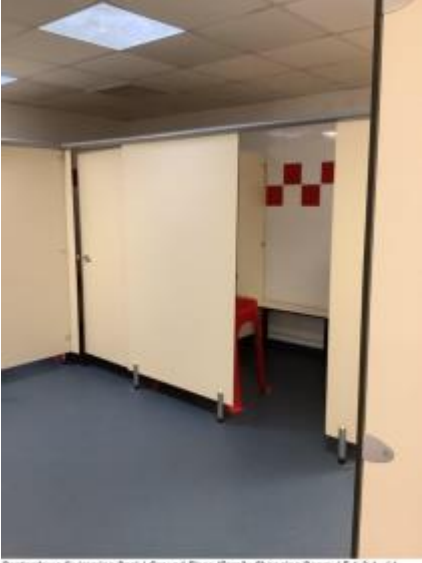
<p data-bbox="842 943 1265 958">Pontardawe Swimming Pool / Ground Floor Family Changing Room / 5.1.2.1. / 1.</p>
<p>Location: Ground Floor Family Changing Room</p> <p>Element Group/Code/Description: 5. Services / 5.8 . Electrical Installations / 5.8.3. Lighting Installations / 5.8.3.6. Luminaires</p> <p>Condition Grade: C</p> <p>Quantity/Unit: 9.00</p> <p>Cost: £ 240.00</p> <p>Comments: Consider replacing LED</p> <p>Defects: End of Serviceable Life.</p> <p>Action: Replace</p>

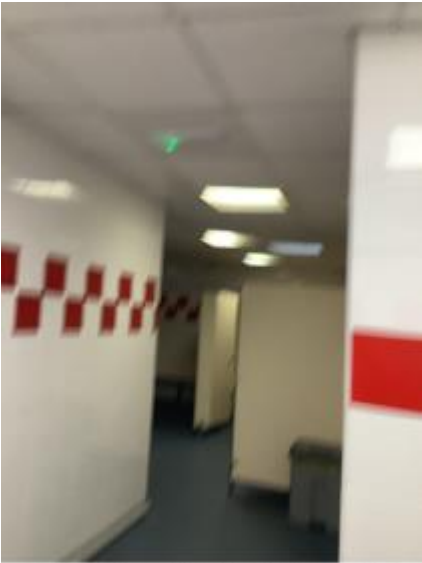
<p data-bbox="842 1668 1265 1684">Pontardawe Swimming Pool / Ground Floor Family Changing Room / 5.8.3.6. / 1.</p>

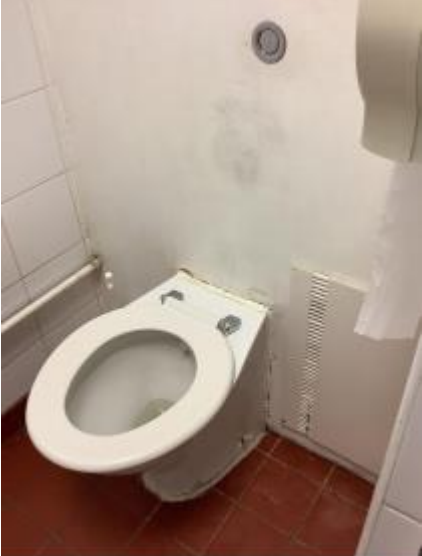
<p>Pontardawe Swimming Pool / Ground Floor Toilets / 5.1.1.10. / 1</p>
<p>Location: Ground Floor Toilets</p> <p>Element Group/Code/Description: 5. Services / 5.1. Sanitary Installations / 5.1.1. Sanitary Appliances / 5.1.1.9. Wash Hand Basin and Taps</p> <p>Condition Grade: C</p> <p>Quantity/Unit: 2.00</p> <p>Cost: £ 380.00</p> <p>Comments: Maintain and repair as required</p> <p>Defects: Fair Condition.</p> <p>Action: Maintain</p>

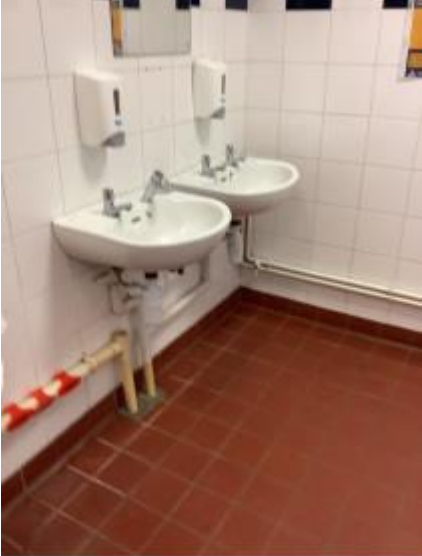
<p>Pontardawe Swimming Pool / Ground Floor Toilets / 5.1.1.9. / 1</p>

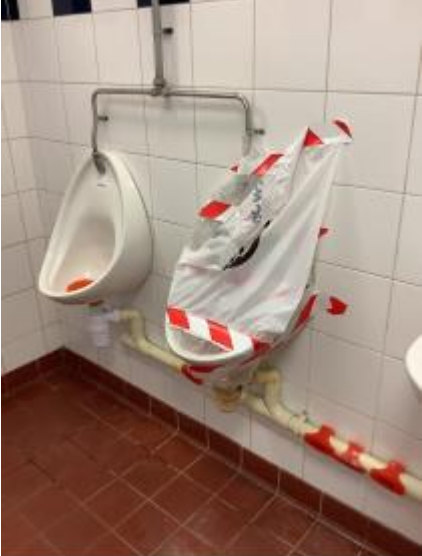
<p data-bbox="842 938 1265 958">Pontardawe Swimming Pool / Ground Floor Toilets / 5.1.1.8. / 1</p>
<p>Location: Ground Floor Toilets</p> <p>Element Group/Code/Description: 5. Services / 5.1. Sanitary Installations / 5.1.2. Sanitary Ancillaries / 5.1.2.4. Hand Dryers</p> <p>Condition Grade: C</p> <p>Quantity/Unit: 2.00</p> <p>Cost: £ 490.00</p> <p>Comments: Run to failure</p> <p>Defects: Fair Condition.</p> <p>Action: Replace</p>

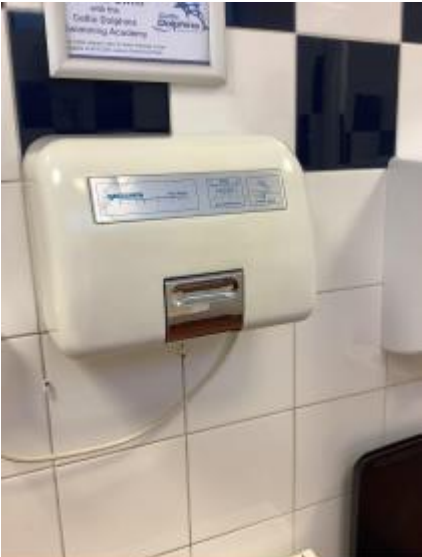
<p data-bbox="842 1664 1265 1684">Pontardawe Swimming Pool / Ground Floor Toilets / 5.1.2.4. / 1</p>

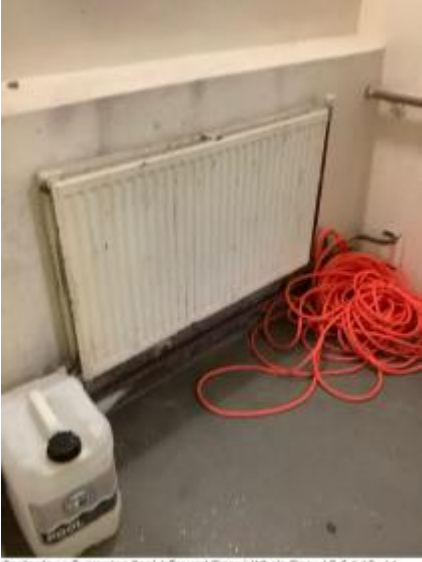
<p data-bbox="842 943 1265 958">Pontardawe Swimming Pool / Ground Floor Whole Floor / 5.6.1.15. / 1</p>
<p>Location: Ground Floor Whole Floor</p> <p>Element Group/Code/Description: 5. Services / 5.6. Space Heating & Air Conditioning / 5.6.1. Central Heating / 5.6.1.15. Radiators</p> <p>Condition Grade: C</p> <p>Quantity/Unit: 10.00</p> <p>Cost: £ 330.00</p> <p>Comments: Poor condition signs of corrosion</p> <p>Defects: End of Serviceable Life.</p> <p>Action: Replace</p>

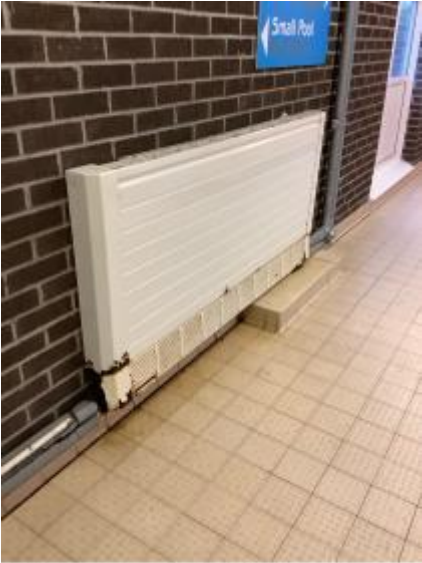
<p data-bbox="842 1706 1265 1722">Pontardawe Swimming Pool / Ground Floor Whole Floor / 5.6.1.15. / 1</p>
