Asset Condition Report – Access Road into Margam Crematorium

- Client: Neighbourhood Services
- Brief: To undertake a survey to determine the total area and surface condition for the private access road into Margam Crematorium; for the purpose of providing options and estimated costs for surface treatment and/or preventative maintenance.
- Location: Private access road into Margam Crematorium, from the junction at Heol Cae'r-Bont (just off the Margam Interchange Roundabout) to the turning circle at the entrance of the Crematorium building.
- Asset Type: Bituminous asphaltic surface, made up with various unspecified aggregate/materials/binders, with unknown road construction.
- Dimensions: Total length – approximately 750 metres, Total area – 5,383 m² (inclusive of car parking layby areas)

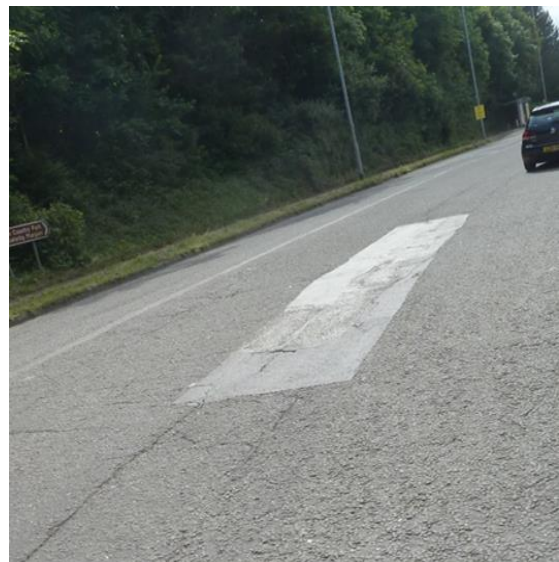
Please note images 6 & 8 in Appendix A show an example of Preventative Treatment using Overbanding – images taken on Margam Interchange Roundabout.

IMAGE 6 – Overbanding Example, Margam Interchange Roundabout.

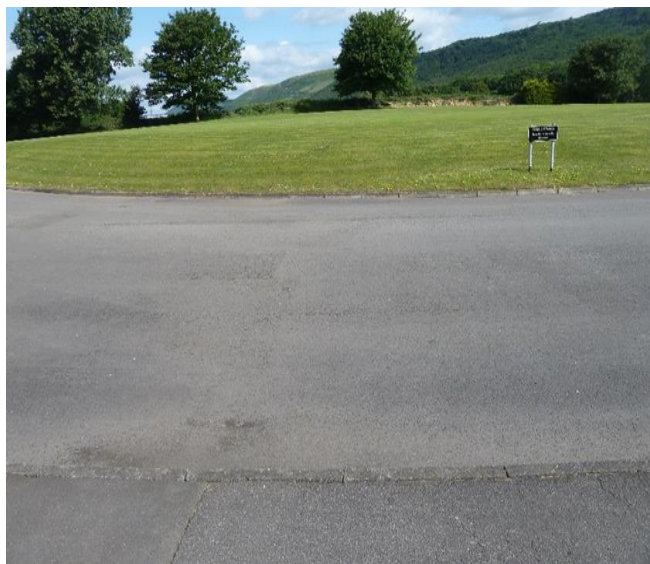
The condition from the Crematorium Entrance to the Turning Circle has defects beginning to show in the wheel track, if this is left untreated, there is a risk for structural failure and the formation of potholes with occur – see images 5 & 7.

As in section 2, the survey also identified deterioration in the wheel track in Section 3 which again, as a minimum, will need preventative treatment before the condition worsens and potholes begin to form – see image 7 in Appendix A.

IMAGE 7 – Deterioration in Wheel Track.

Table 3a - Preventative Treatment (Overbanding)

Treatment	Expected Lifespan (Years)	Area (m ²)	Cost Per m ²	Total Cost (Day time)	Out of Hours Cost
Overbanding (2 no. of 1m x 155m Strips)	3 – 5	310	£25	£7,750	£8,959

Table 3b – Resurfacing

Treatment	Expected Lifespan (Years)	Area (m ²)	Total Cost (Day time)	Cost Per m ²	Out of Hours Cost
Resurfacing	15 – 25	1,052	£20,514	£19.5	£23,715

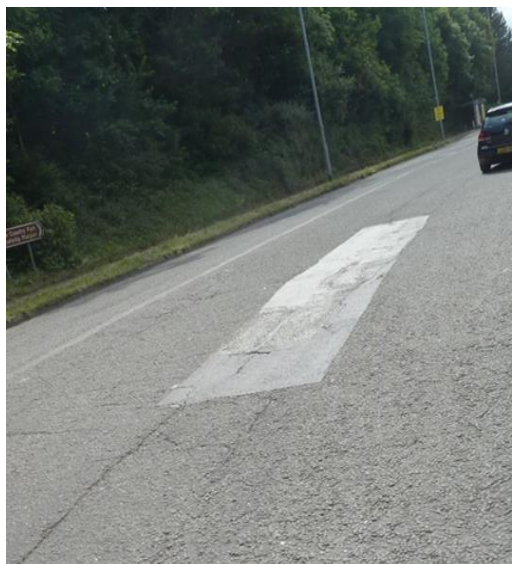
IMAGE 8 – Overbanding Example, Margam Interchange Roundabout.
