Asset Condition Report – Access Road into Margam Crematorium

- Client: Neighbourhood Services
- Brief: To undertake a survey to determine the total area and surface condition for the private access road into Margam Crematorium; for the purpose of providing options and estimated costs for surface treatment and/or preventative maintenance.
- Location: Private access road into Margam Crematorium, from the junction at Heol Cae'r-Bont (just off the Margam Interchange Roundabout) to the turning circle at the entrance of the Crematorium building.
- Asset Type: Bituminous asphaltic surface, made up with various unspecified aggregate/materials/binders, with unknown road construction.
- Dimensions: Total length – approximately 750 metres, Total area – 5,383 m² (inclusive of car parking layby areas)

Appendix A - MARGAM CREMATORIUM IMAGES

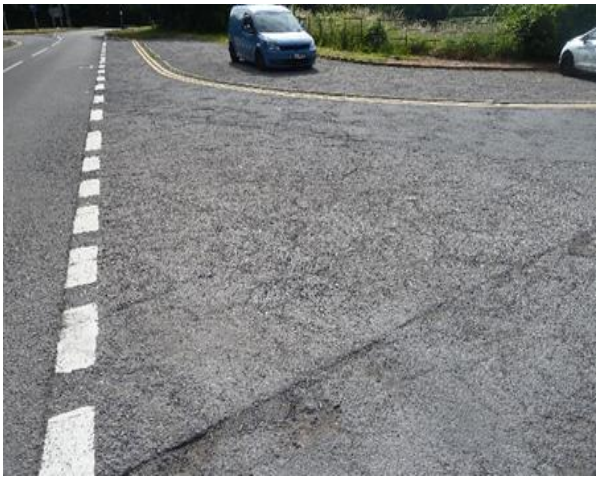
IMAGE 1

The surface condition varies throughout. The condition from the junction to the entrance of the crematorium has numerous defects, where there is now a potential structural failure (image 1 & 2). There are also defects in the wheel track (image 3) and areas where preventative treatment has been previously used (image 4).

Based on the condition of this section of road (see images 1 to 4 in Appendix A), the following surface treatment option is recommended, including estimated costs for daytime working and evenings/overnight/weekends (out-of-hours) working:

Table 1 - Resurfacing

Treatment	Expected Lifespan (Years)	Area (m ²)	Total Cost (Day time)	Cost Per m ²	Out of Hours Cost
Resurfacing	15 – 25	1,382	£26,949	£19.5	£31,154

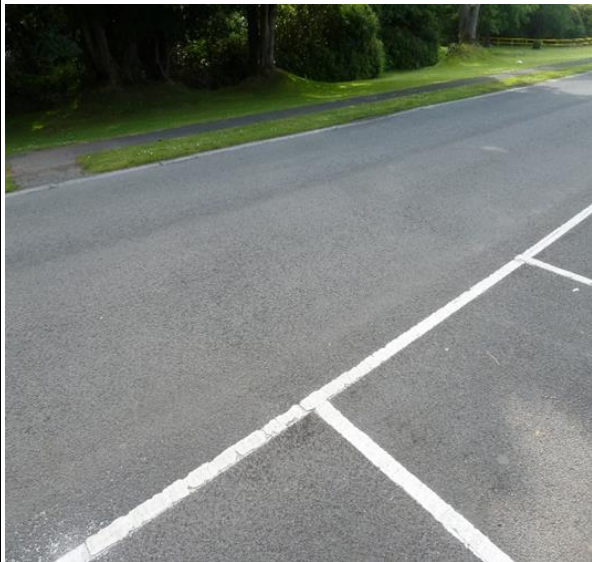
The condition from the Crematorium Entrance to the Turning Circle has defects beginning to show in the wheel track, if this is left untreated, there is a risk for structural failure and the formation of potholes with occur – see images 5 & 7.

The survey identified deterioration in the wheel track which, as a minimum, will need preventative treatment before the condition worsens and potholes begin to form – see image 5 in Appendix A.

IMAGE 5 – Deterioration in Wheel Track

Based on the condition of this section of road, the following surface treatment options can be considered, including estimated costs for daytime working and evenings/overnight/weekends (out-of-hours) working:

Table 2a – Preventative Treatment (Overbanding)

Treatment	Expected Lifespan (Years)	Area (m ²)	Cost Per m ²	Total Cost (Day time)	Out of Hours Cost
Overbanding (2 no. of 1m x 375m Strips)	3 – 5	750	£25	£18,750	£21,675

Table 2b – Resurfacing

Treatment	Expected Lifespan (Years)	Area (m ²)	Total Cost (Day time)	Cost Per m ²	Out of Hours Cost
Resurfacing	15 – 25	2,949	£57,506	£19.5	£66,477

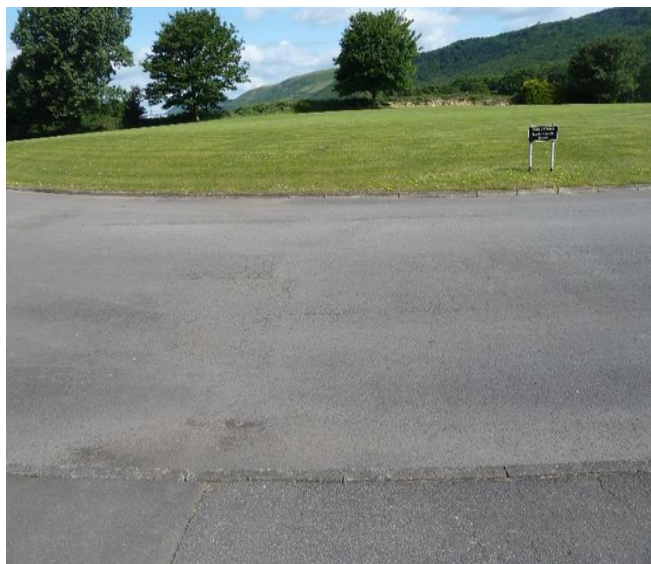
As in section 2, the survey also identified deterioration in the wheel track in Section 3 which again, as a minimum, will need preventative treatment before the condition worsens and potholes begin to form – see image 7 in Appendix A.

IMAGE 7 – Deterioration in Wheel Track.

Based on the condition of this section of road, the following surface treatment options can be considered, including estimated costs for daytime working and evenings/overnight/weekends (out-of-hours) working:

Table 3a - Preventative Treatment (Overbanding)

Treatment	Expected Lifespan (Years)	Area (m ²)	Cost Per m ²	Total Cost (Day time)	Out of Hours Cost
Overbanding (2 no. of 1m x 155m Strips)	3 – 5	310	£25	£7,750	£8,959

Table 3b – Resurfacing

Treatment	Expected Lifespan (Years)	Area (m ²)	Total Cost (Day time)	Cost Per m ²	Out of Hours Cost
Resurfacing	15 – 25	1,052	£20,514	£19.5	£23,715
