**5-006**

**NORTON TERRACE ,  
GLYNCORRWG: Glyncoirwg  
Division**

**General**

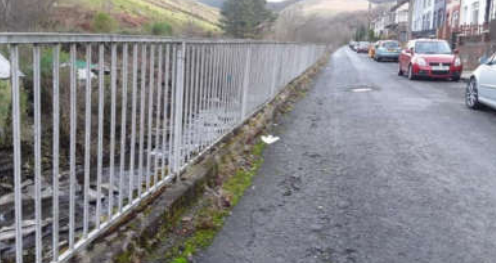
Set	No	Element Description	S	Ex	Def	W	P	Cost	Comments/Remarks
<b>Safety Element</b>								0	parapet railings are loose and leaning towards the roadway these railings require securing.
	10	Carriageway	4	D	9.6		M	£35,000	Dip in carriageway 150mm drop causing a bow in road with longitudinal crack along road, this section of road needs reconstruction.
<b>S- Severity ,Ex - Extent, def - Defect. W - Work Required, P - Work Priority, Cost - Cost of work</b>

Ref No.	Item No.	Work Description	Priority	Estimated Cost	Work Ordered
MA2200044	10	Dip in carriageway 150mm drop causing a bow in road with longitudinal crack along road, this section of road needs reconstruction.	M	£35,000	
MA2200045	9	75% of the parapet railings are loose and leaning towards the roadway these railings require securing.	H	£20,000	
MA2200046	9	Needs replacing throughout	L	£150,000	
MA2200047	2	Sections need replacing throughout its length recommend replace entire wall.	M	£450,000	
MA2200048	4	The concrete plinth is loose and does not support the guard rail, this concrete plinth is sliding towards the river as the retaining wall below plinth has bulges and loose stonework with no support to the concrete plinth.	H	£50,000	
MA2200049	5	Drainage pipe holes along length of wall look blocked and require repair.	M	£10,000	
MA2200050	2	Vegetation and small tree growth causing major damage to wall structure along section length these need removal.	M	£15,000

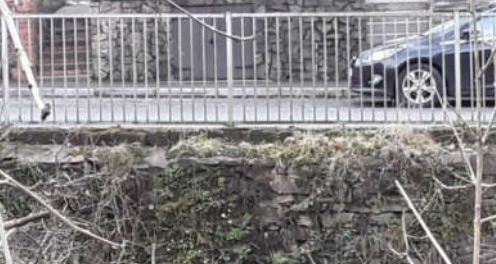
Retaining Wall (Primary)

Element No.	S	Ex	Defect	Comments
2	4	C	5.1	Vegetation and small tree growth causing major damage to wall structure along section length these need removal.
9	5	D	1.5	75% of the parapet railings are loose and leaning towards the roadway these railings require securing.

No.	Comments				
	It is recommended that the wall be reconstructed.				
Name	Paul Ransome	Signed

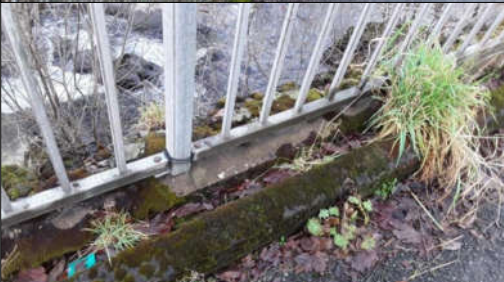
Inspection Type: General		Form No.: 1 of 1		Description: Form 1					
Inspector: David Griffiths		Date: 04/12/2020 11:41		Next Inspection:					
Name: NORTON TERRACE , GLYNCORRWG (5-006)		Road Ref: Norton Terrace							
Map Ref: OS: SS88019934		Primary Str. Form:							
Width: 0.65		Length: 372		Primary Material: RC					
All Above Ground Elements Inspected: Yes		Secondary Str. Form:							
		Secondary Material:							
Set	No	Element Description	S	Ex	Def	W	P	Cost	Comments/Remarks
<b>Main Els.</b>	1	Foundations	1	A					Parts of the concrete foundation can be inspected.
	2	Retaining Wall (Primary)	4	D	3.7		M	£465,000	Vegetation and small tree growth causing major damage to wall structure along section length these need removal. Sections need replacing throughout its length recommend replace entire wall.
	4	concrete plinth	4	D	3.7		H	£50,000	The concrete plinth is loose and does not support the guard rail, this concrete plinth is sliding towards the river as the retaining wall below plinth has bulges and loose stonework with no support to the concrete plinth.

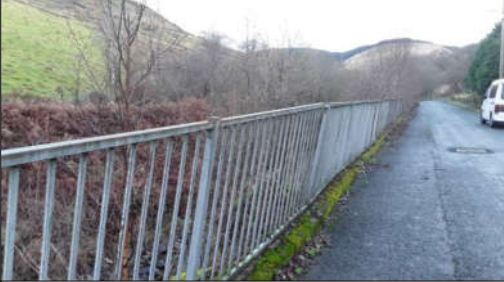
<b>Durability Elements</b>	5	Drainage	3	C	8.4		M	£10,000	Drainage pipe holes along length of wall look blocked and require repair.
	9	Handrail/parapet/safety fences	5	D	1.1		H	£170,00	Needs replacing throughout. 75% of the
