6-170

Bevans Terrace Retaining Wall:
Pelenna Division

Inspection Type: General	Form No.: 1 of 1	Description:	
Inspector: David Griffiths	Date: 05/04/2022 11:12	Next Inspection:	
Name:	Bevans Terrace Retaining Wall (6-170)	Road Ref:	B4287 main Road, Ponrhydyfen

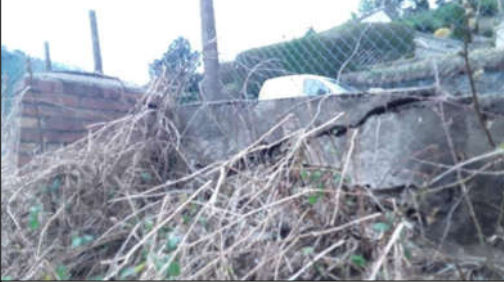
Retaining Wall (Primary)	6-170-220405110807.jpg

Map Ref:	OS:	SS79029467			Primary Str. Form:				
Width:	60	Length:	0.65		Primary Material:		B		
All Above Ground Elements Inspected:			Yes		Secondary Str. Form:				
					Secondary Material:				
Set	No	Element Description	S	Ex	Def	W	P	Cost	Comments/Remarks
Main Els.	1	Foundations	4	C	6.1		H	£0	There are large sections were it appears that there are no or very limited foundations
	2	Retaining Wall (Primary)	4	C	3.7	N	H	£250,000	The concrete dwarf wall is heavily cracked and is bulging. it has partially collapses at one location and a major dip in footpath and roadway adjacent to no 5 for a section of 10m this section requires replacing as asap as there is no support to the footpath and roadway.
Safety Elements	10	Carriageway	4	C	9.6		M	£150,000	Heavy longitudinal cracking and deformation in the road opposite no 5 where the concrete wall has partially collapsed
	12	Footway/Verge	4	C	3.7	R	H	£25,000	There is cracking to the footpath surfacing throughout the length of the wall but there is a significant deformation above the area where the wall has partially collapsed.

No.	Comments	Comment Type		
	The wall needs to be rebuilt along with the footpath & the adjacent carriageway	Engineers Comment		
	The concrete plinth has given way causing cracking and a major dip in footpath and roadway adjacent to no 5 for a section of 10m this section requires replacing as asap as there is no support to the footpath and carriageway.	Inspectors Comment		
Name	David Griffiths	Signed	Date	05/04/2022 00:00

No.	Comments			
	The wall needs to be rebuilt along with the footpath & the adjacent carriageway			
Name	Paul Ransome	Signed	Date	15/04/2022 00:00

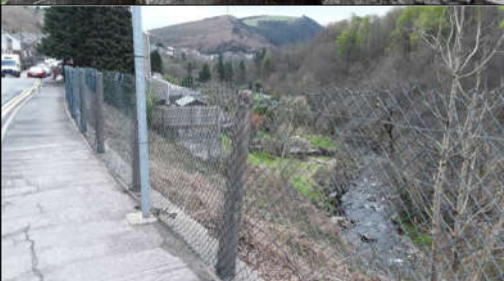
Chain link Fencing	6-170-220405105213.jpg

Other Elements	14	Concrete Posts	4	C	3.7	R	M	£50,000	These are substandard by design. 6 no of concrete posts leaning towards river these need replacing with new concrete plinth of 10m
	15	Chain link Fencing	1	A	1.2		N	£0	Good condition
S- Severity ,Ex - Extent, def - Defect. W - Work Required, P - Work Priority, Cost - Cost of work
