Gelli Houses Disused Railway  
Tunnel: Cymmer Division

General Inspection

Inspection Type: General Inspection	Form No.: 1 of 2	Description: Span 1 - Brick Lined
Inspector: Paul Ransome	Date: 12/06/2021 00:00	Next Inspection:
Name: Gelli Houses Disused Railway Tunnel (815)	Road Ref:

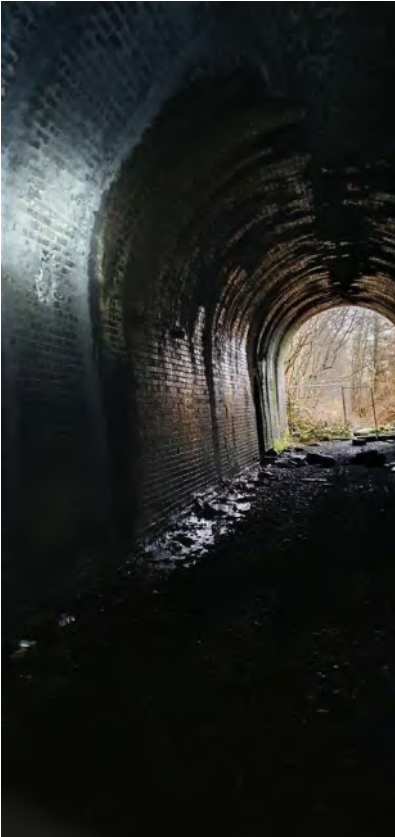
Inspection Item No.	Reference	Photo	Photo Description
9	2101895

Abutments (incl. arch springing)
9	2101896

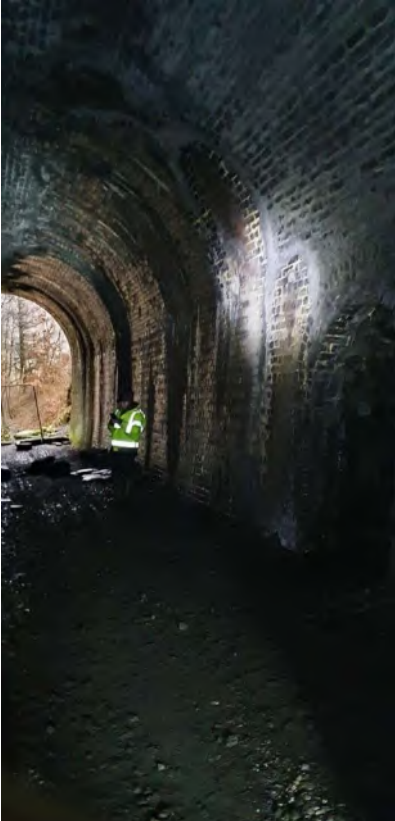
Abutments (incl. arch springing)

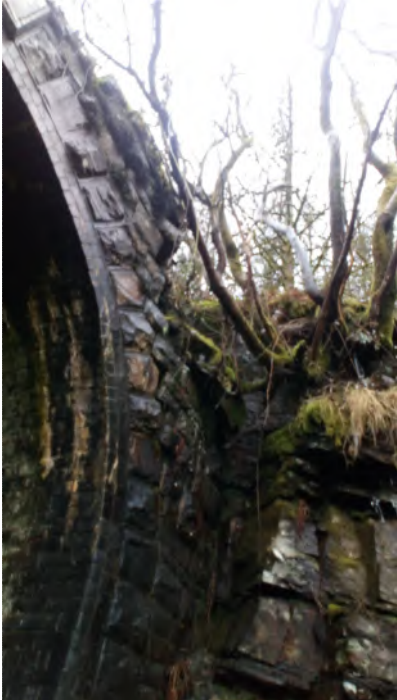
Inspection Item No.	Reference	Photo	Photo Description
10	2101845

Spandrel wall/head wall
10	2101846

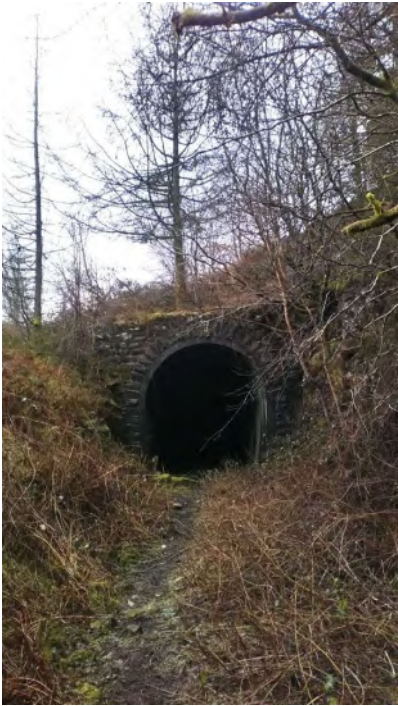
Inspection Item No.	Reference	Photo	Photo Description
33	2101851

Embankments

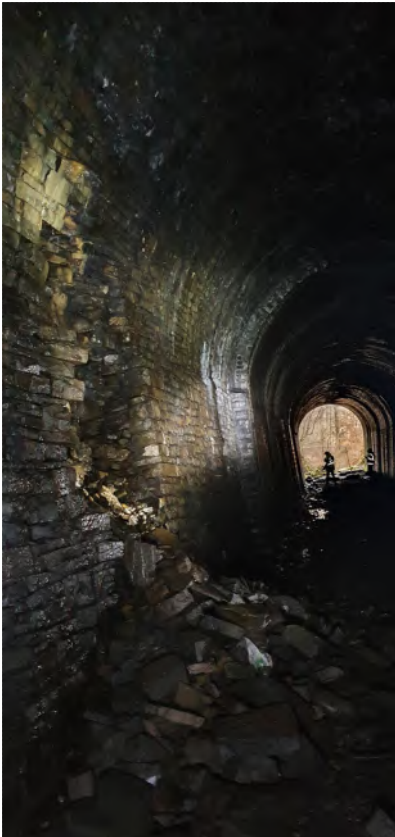
Inspection Item No.	Reference	Photo	Photo Description
9	2101867

Abutments (incl. arch springing)
9	2101868

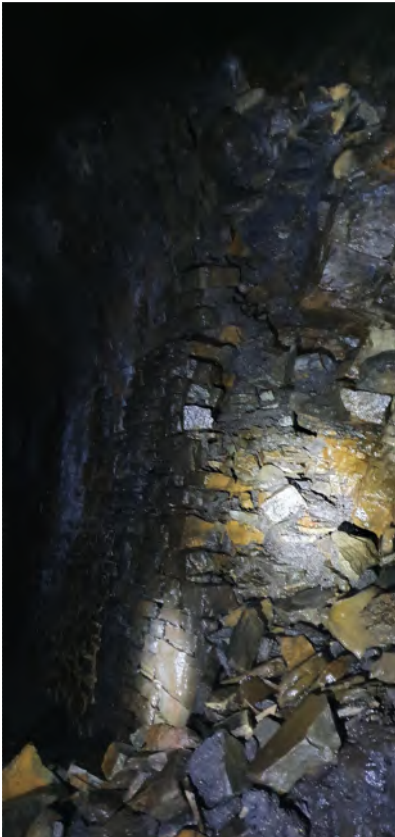
Inspection Item No.	Reference	Photo	Photo Description
9	2101870

Abutments (incl. arch springing)
9	2101871

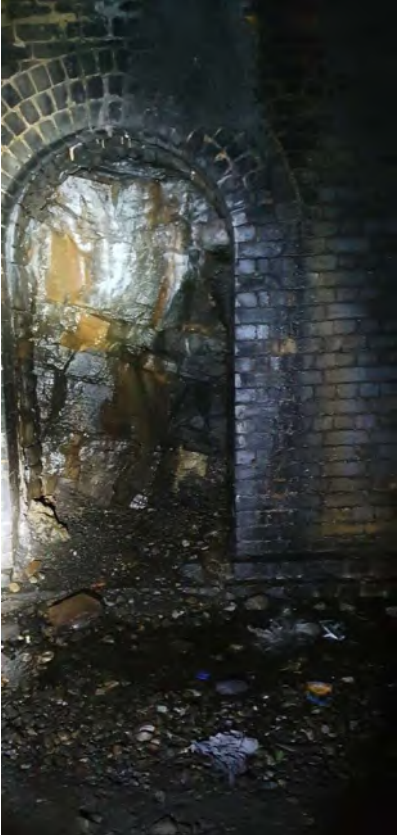
Inspection Item No.	Reference	Photo	Photo Description
17	2101885

Water Proofing
23	2101886
