Godre'r Graig Primary School, Godre'r Graig
Tip Remediation Assessment

Report Reference: ESP.7234e.04.3564

Godre'r Graig Primary School
Tip Remediation Assessment

Prepared for:
Neath Port Talbot County Borough Council
The Quays, Baglan Energy Park,
Brunel Way, Briton Ferry,
SA11 2GG

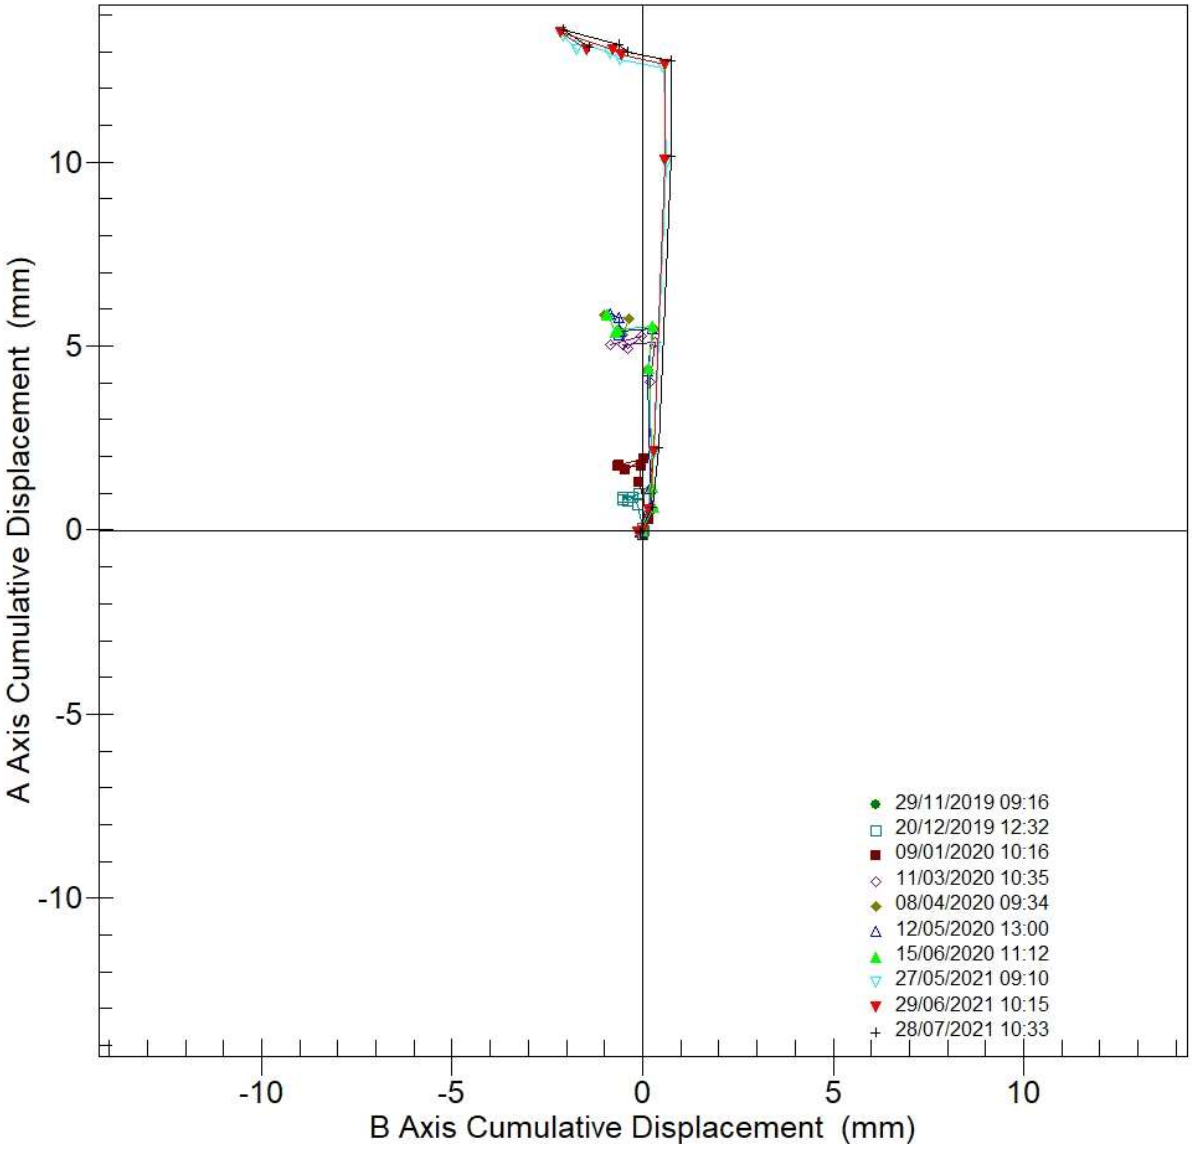
7234e:BH01 - A Axis vs B Axis

The inclinometer was installed to a depth of 5.3m and the base of the Quarry Spoil Tip in this borehole is at 4m depth. Monitoring has shown movement between depths of about 3.5m to 2.5m toward the valley floor (downhill), in the order of 14mm.

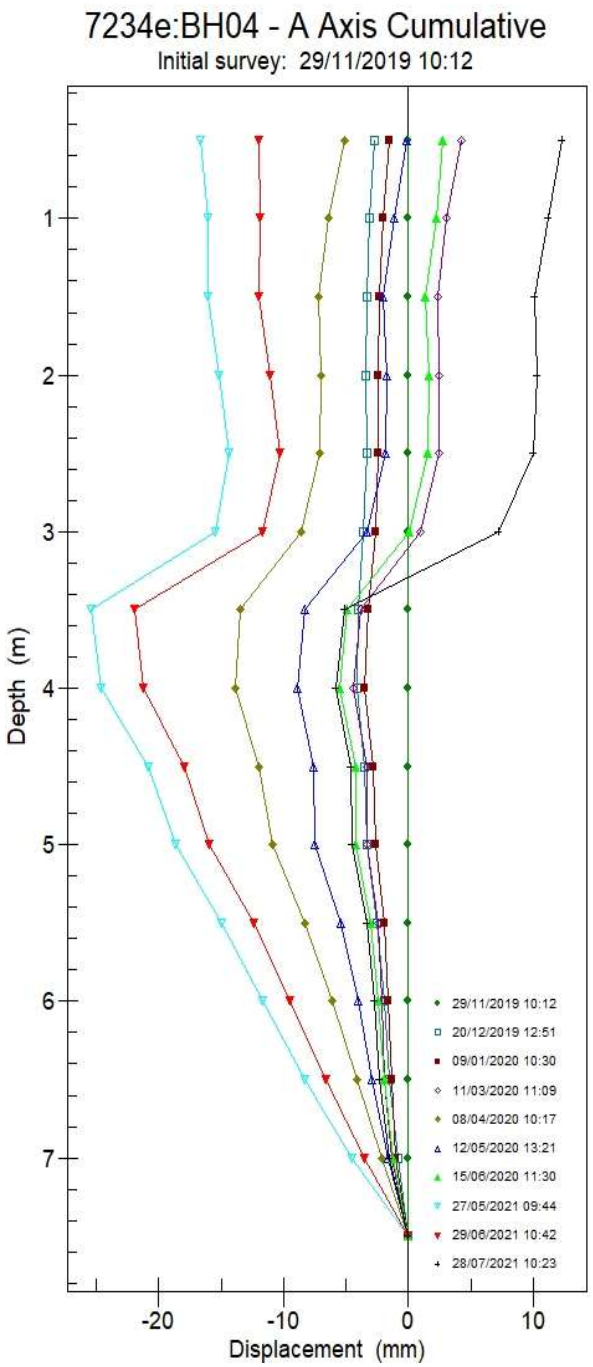
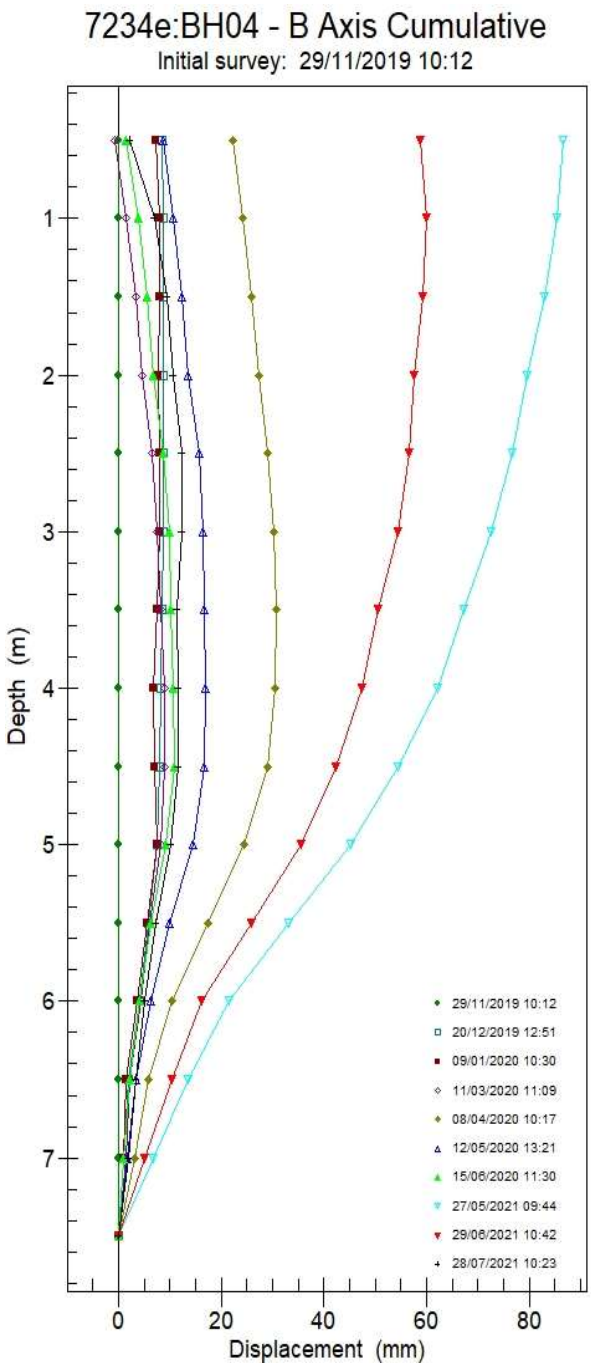
PROJECT:
SITE: 7234e
INSTALLATION: BH04
COMPANY:
CLIENT:

Recent monitoring of the Quarry Spoil Tip has indicted clear ground movement towards the school (~15mm downhill movement to date, see results Appendix A). Our previous assessment suggested that the Quarry Spoil Tip was *Marginally Stable*, i.e., that it was likely to fail at some time in response to destabilising forces reaching a certain level of activity. The information from the inclinometers suggest that the Quarry Spoil Tip is moving and may be ***Actively Unstable*, i.e., destabilising forces are producing continuous or intermittent movements**.

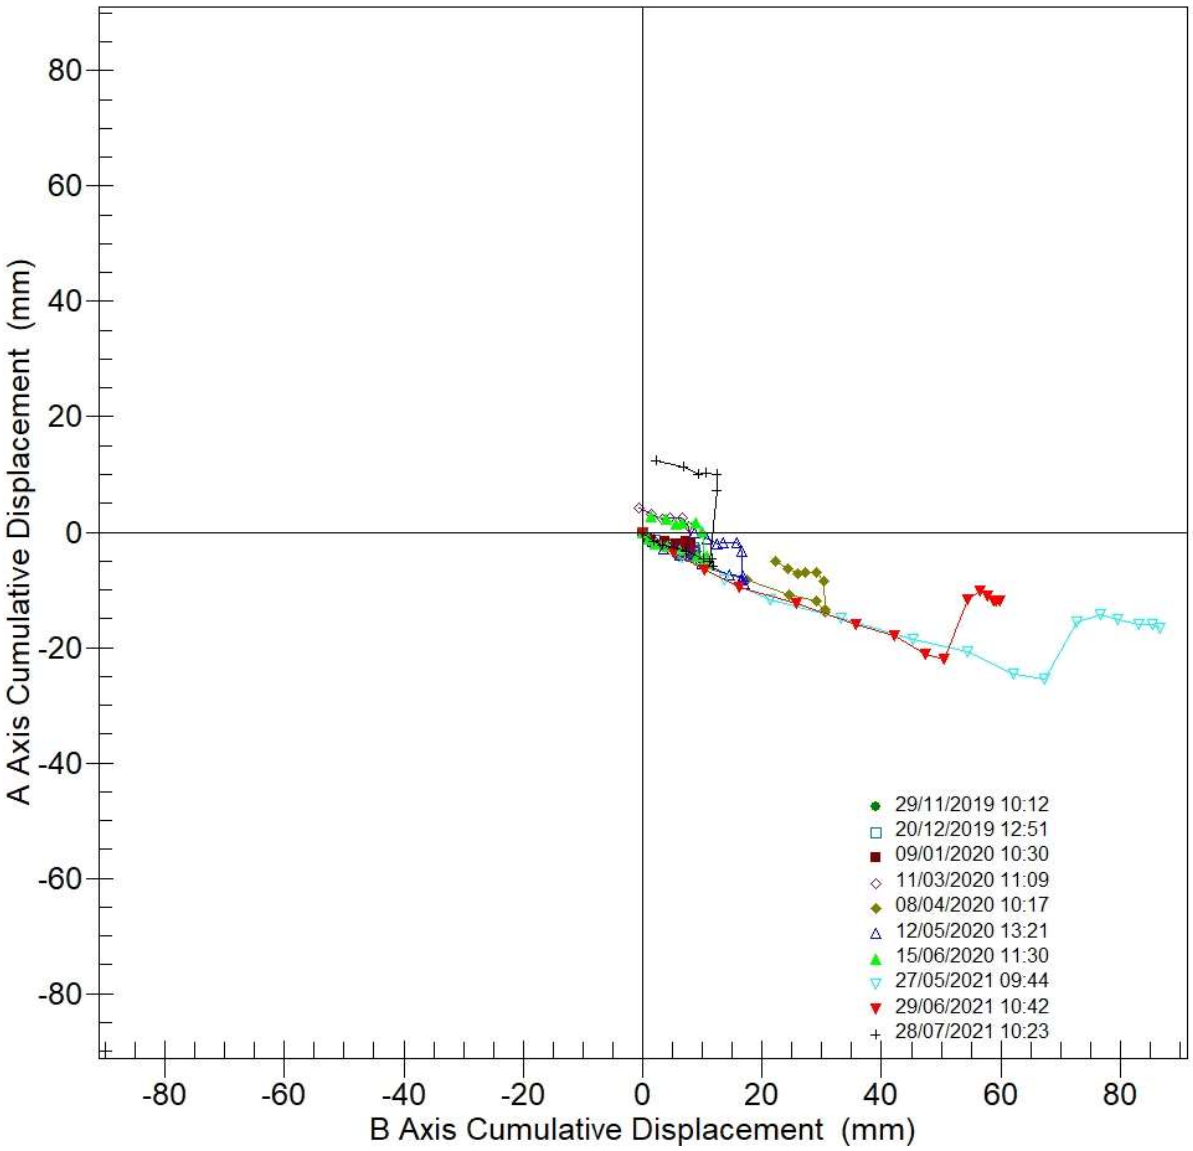
7234e:BH04 - A Axis vs B Axis

The inclinometer in BH04 was installed to a depth of 7.2m and the quarry Spoil Tip extends to a depth of 6m. The data from the monitoring is not conclusive; it may be that the base of the installation is moving with surrounding soils. The graphs do however suggest movement, in the region of 25mm, and for the lower half to be moving more than the upper half.

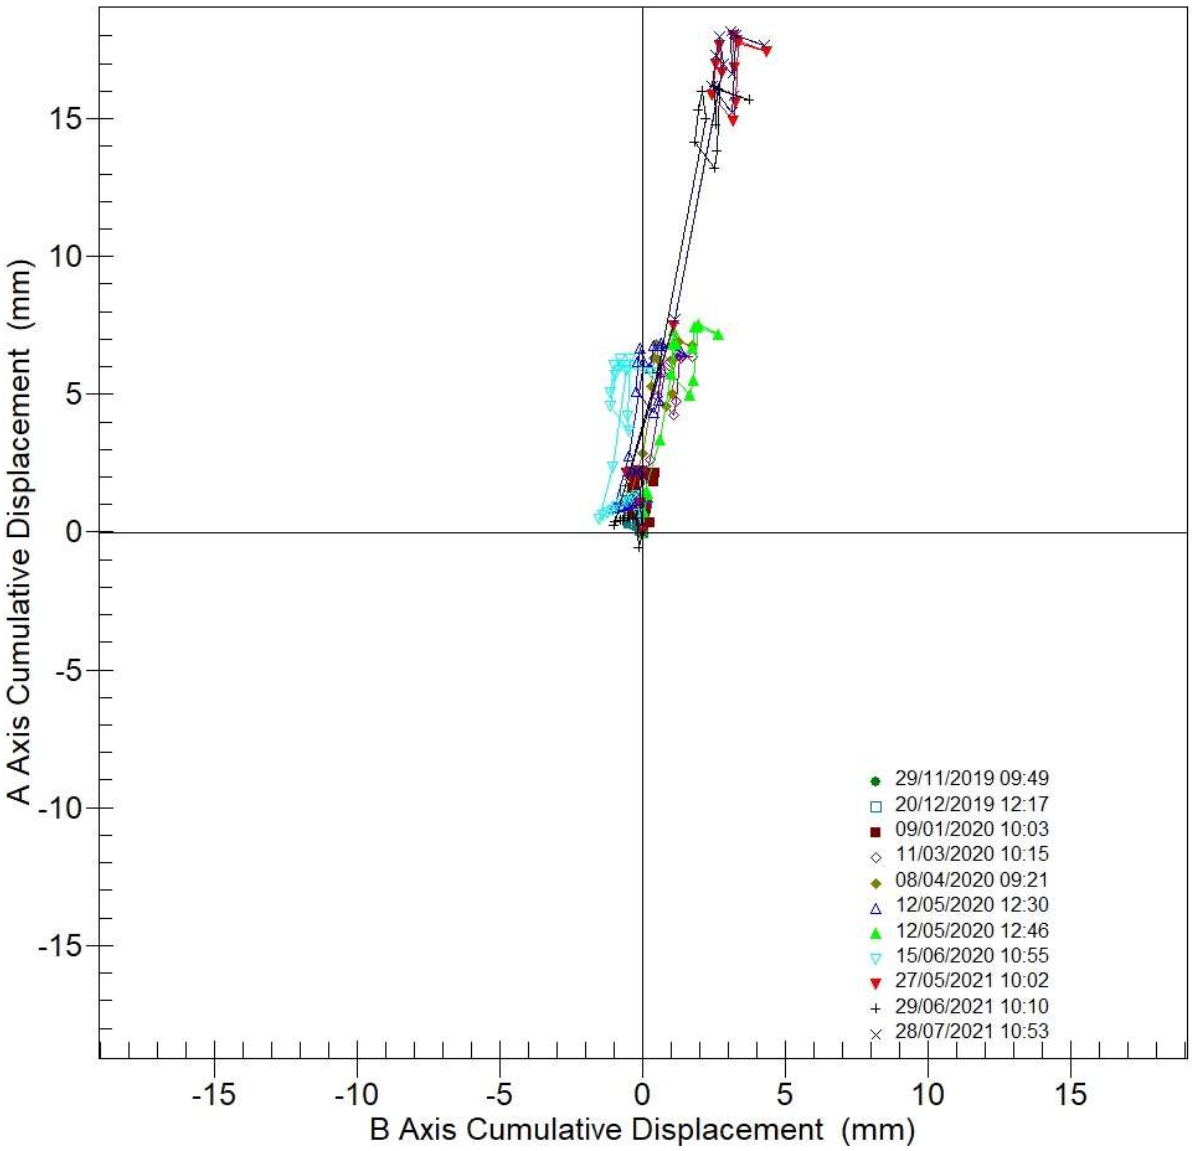
7234e:BH05 - A Axis vs B Axis

The quarry Spoil Tip material extends to a depth of 5.2m in BH05 and the inclinometer extends to a depth of 11.2m. Monitoring has shown movement toward the base of the Quarry Spoil Tip and potentially in the underlying soils at a depth of around 5m to 6m, where it has cumulatively moved approximately 18mm. Movement has also been measured at shallow depth in the installation, within the body of the Quarry Spoil Tip material.

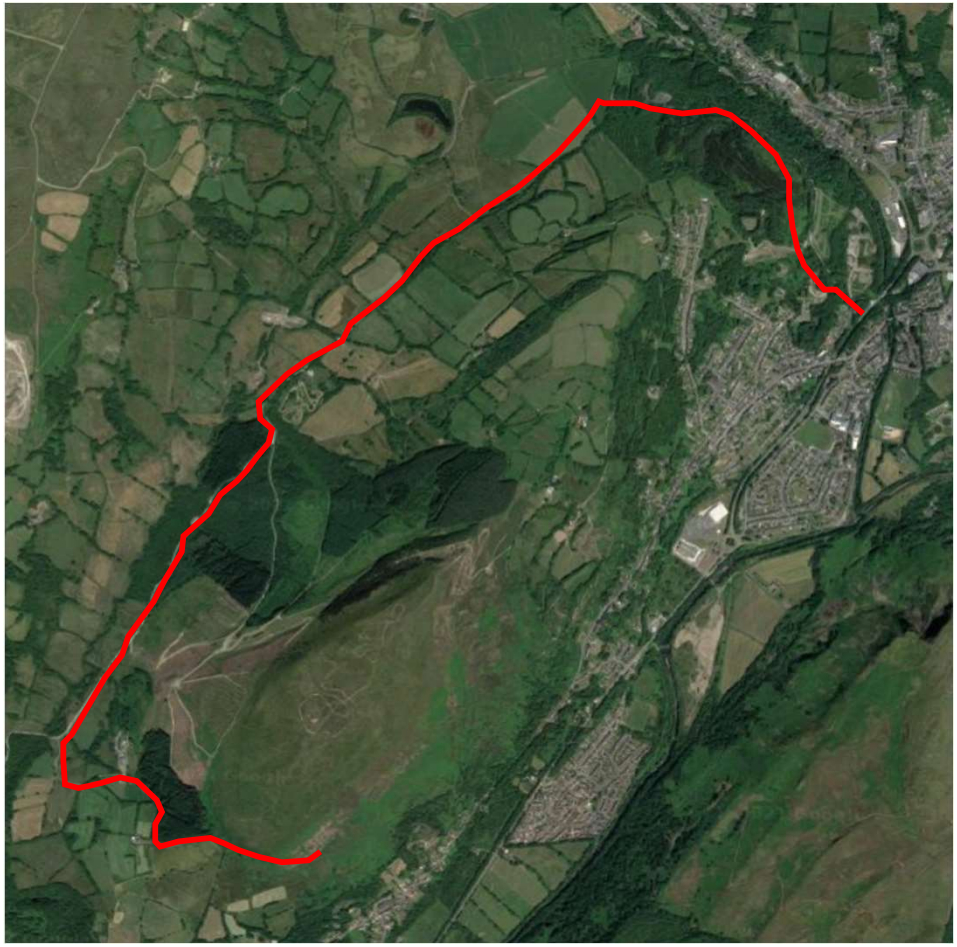
Proposed Access Route 1

Proposed access route 1 from A4067 using existing quarry entrance and track, plus additional track across farm land. The majority of the tip material will be excavated and transported by articulated trucks to a temporary stockpile before been loaded onto road lorries and sent to tip.

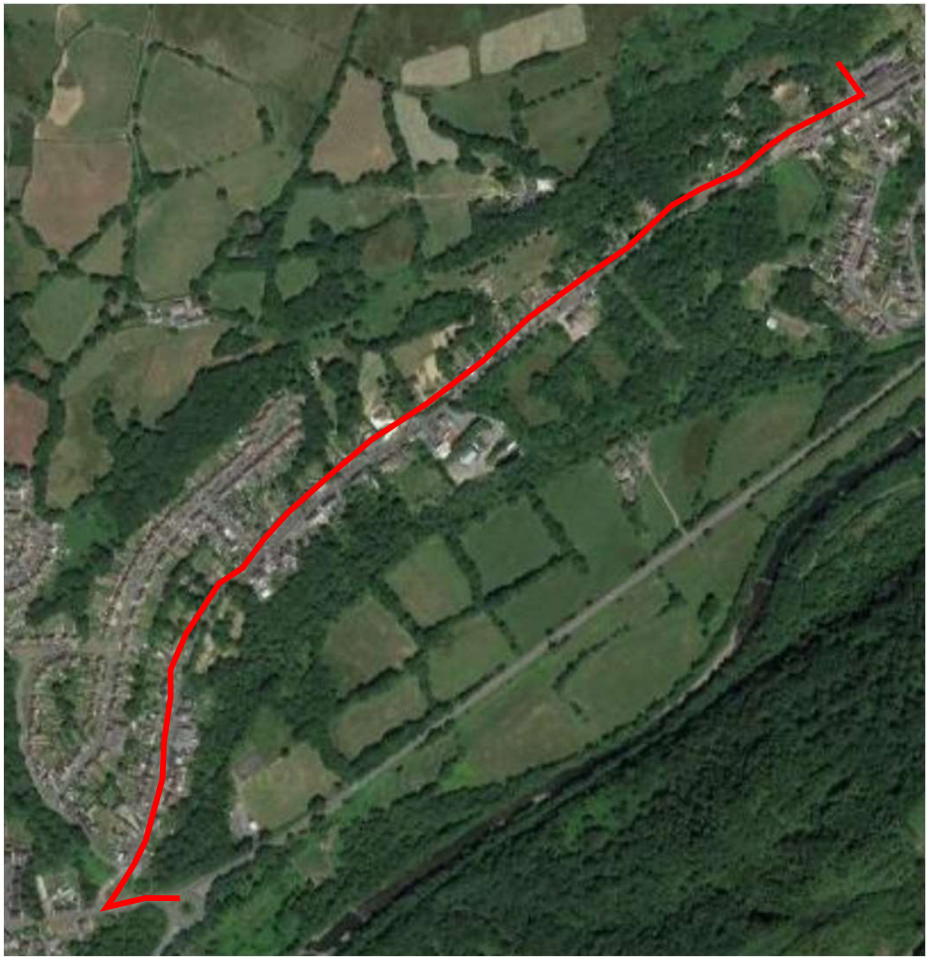
Proposed Access Route 2

Proposed access route 2 along Cilmaengwyn/Graig Road and up the widened primary school car park access road. This access will be utilised to remove any tip material that can't be transported up to route 1. The primary school car park will be used for turning and stacking lorries ready for loading to ensure the highway is kept clear.
