Asset Condition Report – Access Road into Margam Crematorium

- Client: Neighbourhood Services
- Brief: To undertake a survey to determine the total area and surface condition for the private access road into Margam Crematorium; for the purpose of providing options and estimated costs for surface treatment and/or preventative maintenance.
- Location: Private access road into Margam Crematorium, from the junction at Heol Cae'r-Bont (just off the Margam Interchange Roundabout) to the turning circle at the entrance of the Crematorium building.
- Asset Type: Bituminous asphaltic surface, made up with various unspecified aggregate/materials/binders, with unknown road construction.
- Dimensions: Total length – approximately 750 metres, Total area – 5,383 m² (inclusive of car parking layby areas)

Appendix A - MARGAM CREMATORIUM IMAGES

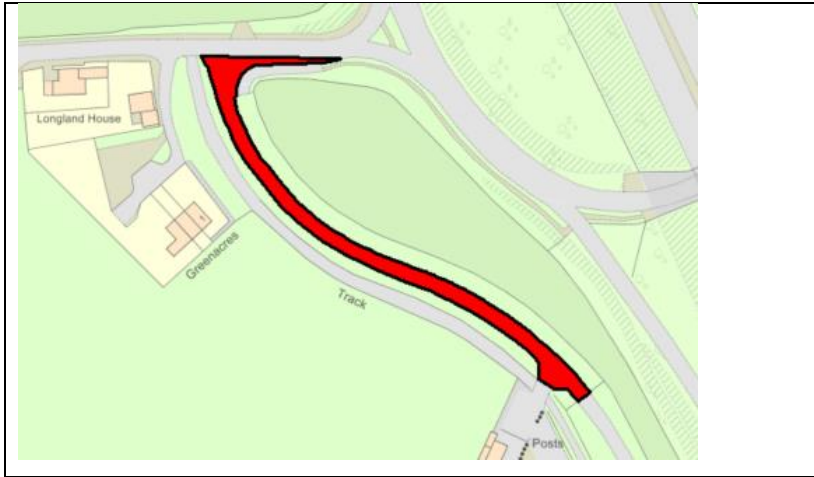
Section 1 (Length - approximately 200 metres, Area – 1,382 m²)

Area: Heol Cae'r-Bont Junction (Off Margam Interchange roundabout) to Crematorium Entrance – *Extent is shown in Appendix A.*

SECTION 1: EXTENT – This is the area that Section 1 covers.
--

Based on the condition of this section of road (see images 1 to 4 in Appendix A), the following surface treatment option is recommended, including estimated costs for daytime working and evenings/overnight/weekends (out-of-hours) working:

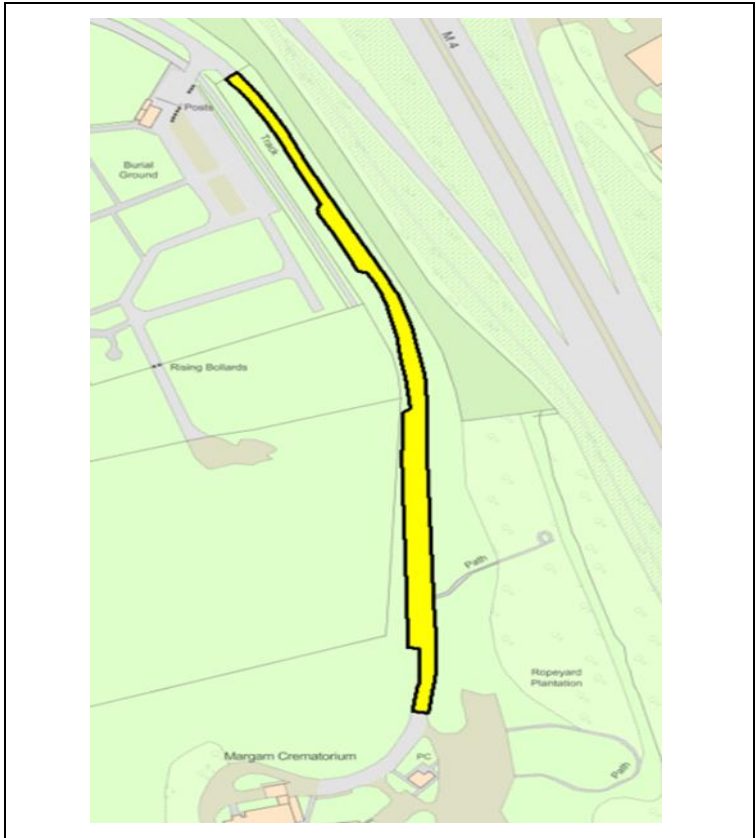
Section 2 (Length - approximately 375 metres, Area – 2,949 m²)

Area: Crematorium Entrance to Crematorium Car Park.

Section 2: Extent - This is the area that Section 2 covers.

Based on the condition of this section of road, the following surface treatment options can be considered, including estimated costs for daytime working and evenings/overnight/weekends (out-of-hours) working:

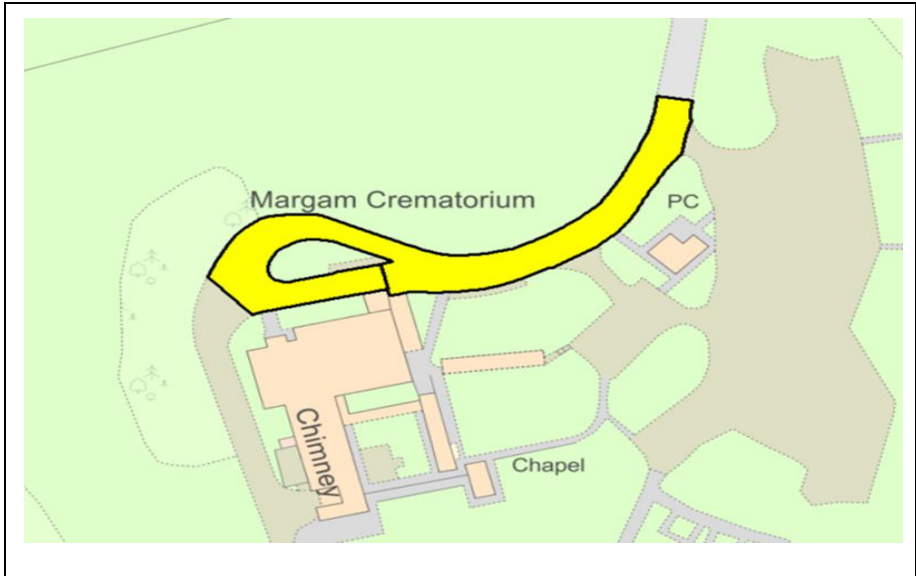
Section 3 (Length - approximately 155 metres, Area – 1052 m²)

Area: Crematorium Car Park to Crematorium Turning Circle

Section 3: Extent - This is the area that Section 3 covers.

Based on the condition of this section of road, the following surface treatment options can be considered, including estimated costs for daytime working and evenings/overnight/weekends (out-of-hours) working:

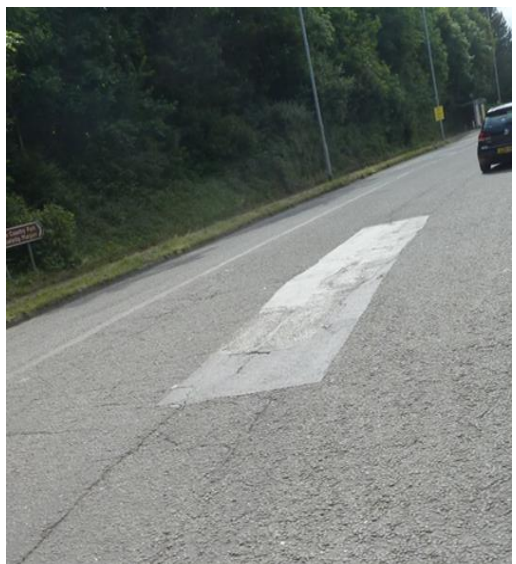
Please note images 6 & 8 in Appendix A show an example of Preventative Treatment using Overbanding – images taken on Margam Interchange Roundabout.

IMAGE 8 – Overbanding Example, Margam Interchange Roundabout.
