**5-006**

**NORTON TERRACE ,  
GLYNCORRWG: Glyncoirwg  
Division**

**General**

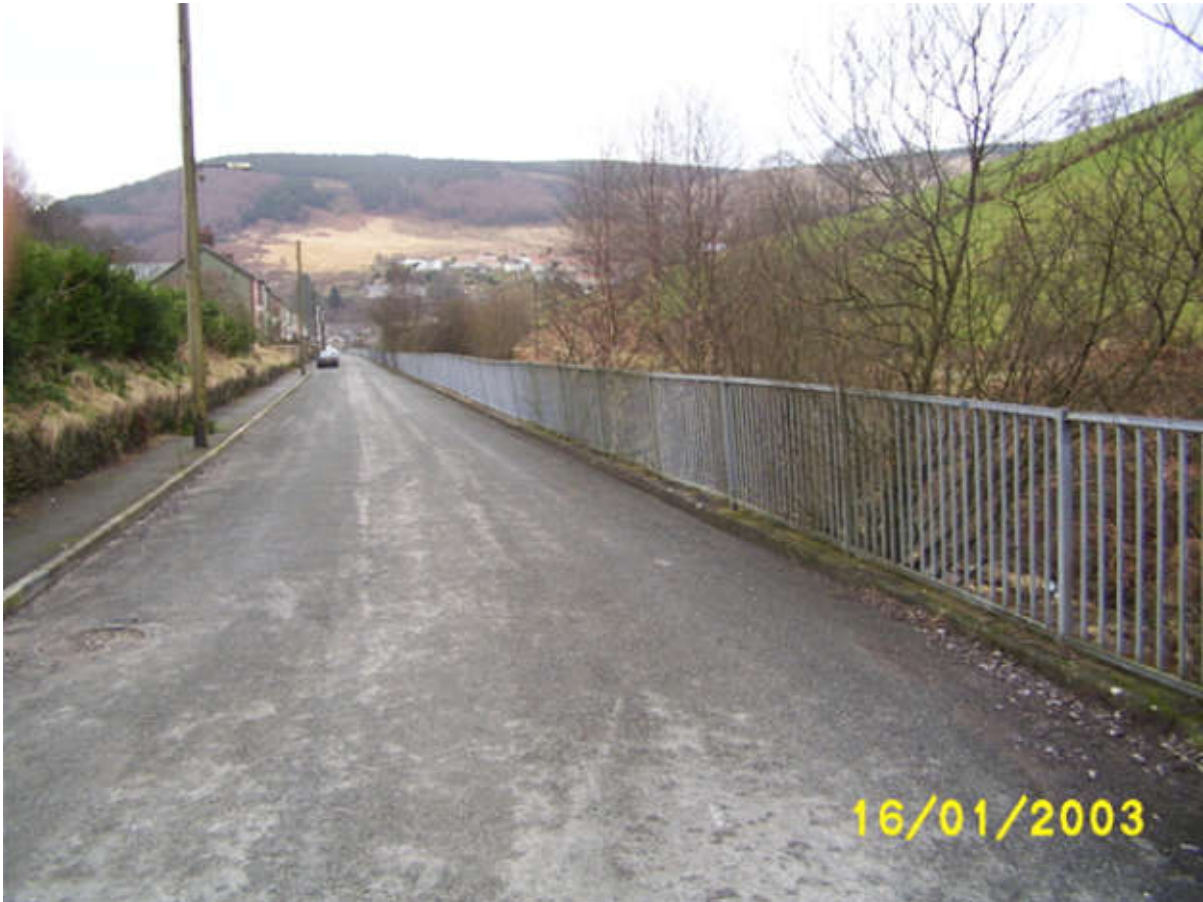
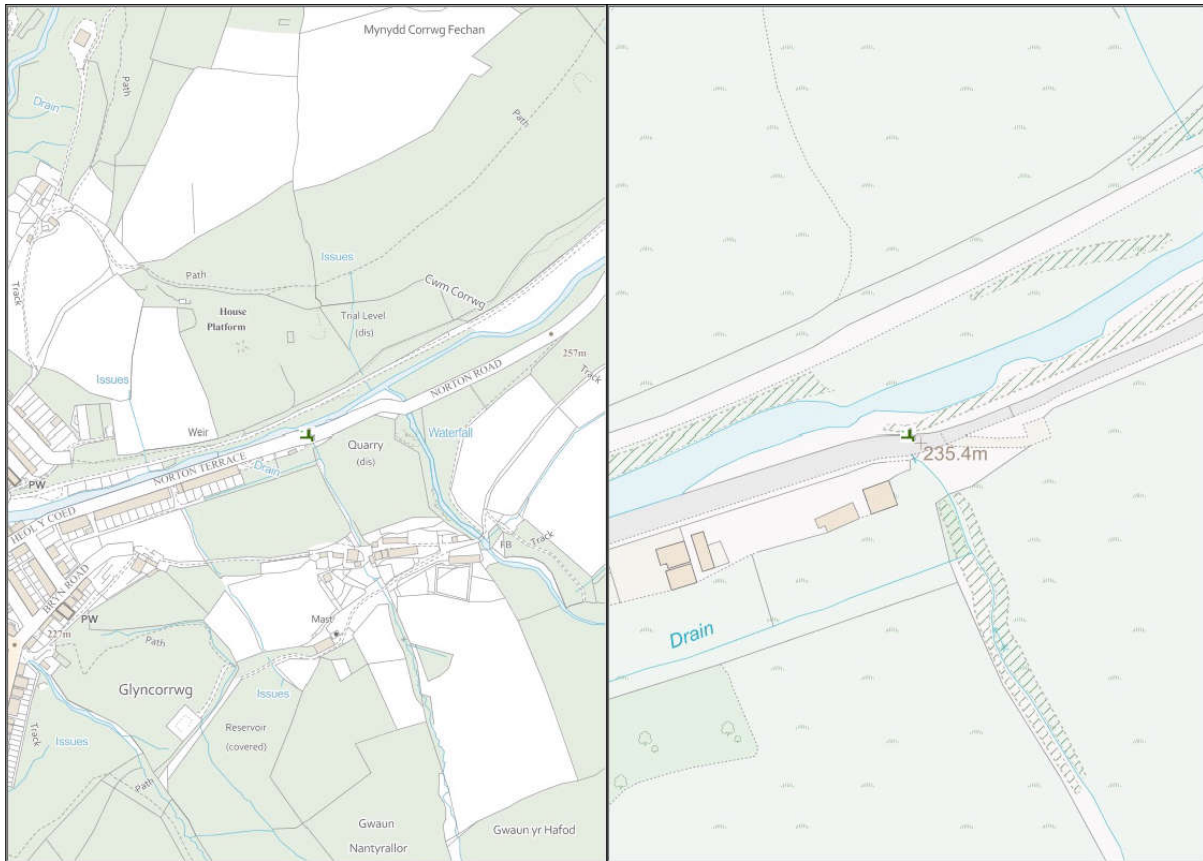
Inspection Type: General		Form No.: 1 of 1		Description: Form 1					
Inspector: David Griffiths		Date: 04/12/2020 11:41		Next Inspection:					
Name: NORTON TERRACE , GLYNCORRWG (5-006)		Road Ref: Norton Terrace							
Map Ref: OS: SS88019934		Primary Str. Form:							
Width: 0.65		Length: 372		Primary Material: RC					
All Above Ground Elements Inspected: Yes		Secondary Str. Form:							
		Secondary Material:							
Set	No	Element Description	S	Ex	Def	W	P	Cost	Comments/Remarks
<b>Main Els.</b>	1	Foundations	1	A					Parts of the concrete foundation can be inspected.
	2	Retaining Wall (Primary)	4	D	3.7		M	£465,000	Vegetation and small tree growth causing major damage to wall structure along section length these need removal. Sections need replacing throughout its length recommend replace entire wall.
	4	concrete plinth	4	D	3.7		H	£50,000	The concrete plinth is loose and does not support the guard rail, this concrete plinth is sliding towards the river as the retaining wall below plinth has bulges and loose stonework with no support to the concrete plinth.

<b>Durability Elements</b>	5	Drainage	3	C	8.4		M	£10,000	Drainage pipe holes along length of wall look blocked and require repair.
	9	Handrail/parapet/safety fences	5	D	1.1		H	£170,00	Needs replacing throughout. 75% of the

Set	No	Element Description	S	Ex	Def	W	P	Cost	Comments/Remarks
<b>Safety Element</b>								0	parapet railings are loose and leaning towards the roadway these railings require securing.
	10	Carriageway	4	D	9.6		M	£35,000	Dip in carriageway 150mm drop causing a bow in road with longitudinal crack along road, this section of road needs reconstruction.
<b>S- Severity ,Ex - Extent, def - Defect. W - Work Required, P - Work Priority, Cost - Cost of work</b>

Element No.	S	Ex	Defect	Comments
2	4	C	5.1	Vegetation and small tree growth causing major damage to wall structure along section length these need removal.
9	5	D	1.5	75% of the parapet railings are loose and leaning towards the roadway these railings require securing.

No.	Comments				
	It is recommended that the wall be reconstructed.				
Name	Paul Ransome	Signed

Ref No.	Item No.	Work Description	Priority	Estimated Cost	Work Ordered
MA2200044	10	Dip in carriageway 150mm drop causing a bow in road with longitudinal crack along road, this section of road needs reconstruction.	M	£35,000	
MA2200045	9	75% of the parapet railings are loose and leaning towards the roadway these railings require securing.	H	£20,000	
MA2200046	9	Needs replacing throughout	L	£150,000	
MA2200047	2	Sections need replacing throughout its length recommend replace entire wall.	M	£450,000	
MA2200048	4	The concrete plinth is loose and does not support the guard rail, this concrete plinth is sliding towards the river as the retaining wall below plinth has bulges and loose stonework with no support to the concrete plinth.	H	£50,000	
MA2200049	5	Drainage pipe holes along length of wall look blocked and require repair.	M	£10,000	
MA2200050	2	Vegetation and small tree growth causing major damage to wall structure along section length these need removal.	M	£15,000
