6-170

Bevans Terrace Retaining Wall:
Pelenna Division

Inspection Type: General	Form No.: 1 of 1	Description:	
Inspector: David Griffiths	Date: 05/04/2022 11:12	Next Inspection:	
Name:	Bevans Terrace Retaining Wall (6-170)	Road Ref:	B4287 main Road, Ponrhydyfen

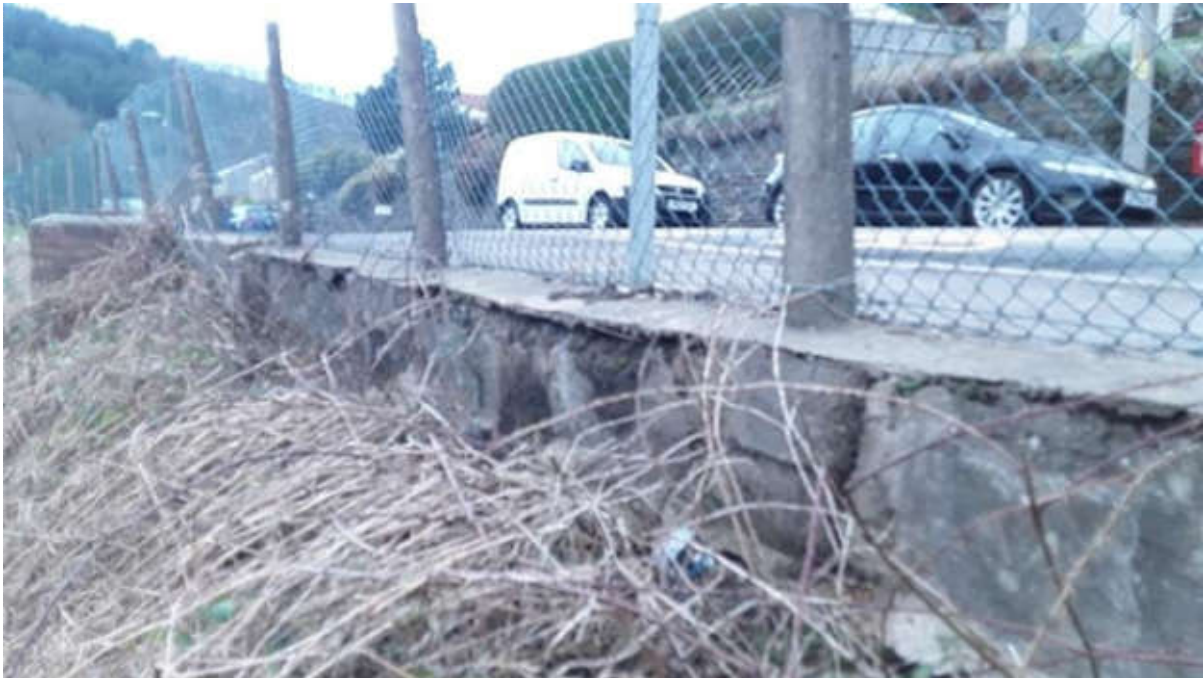
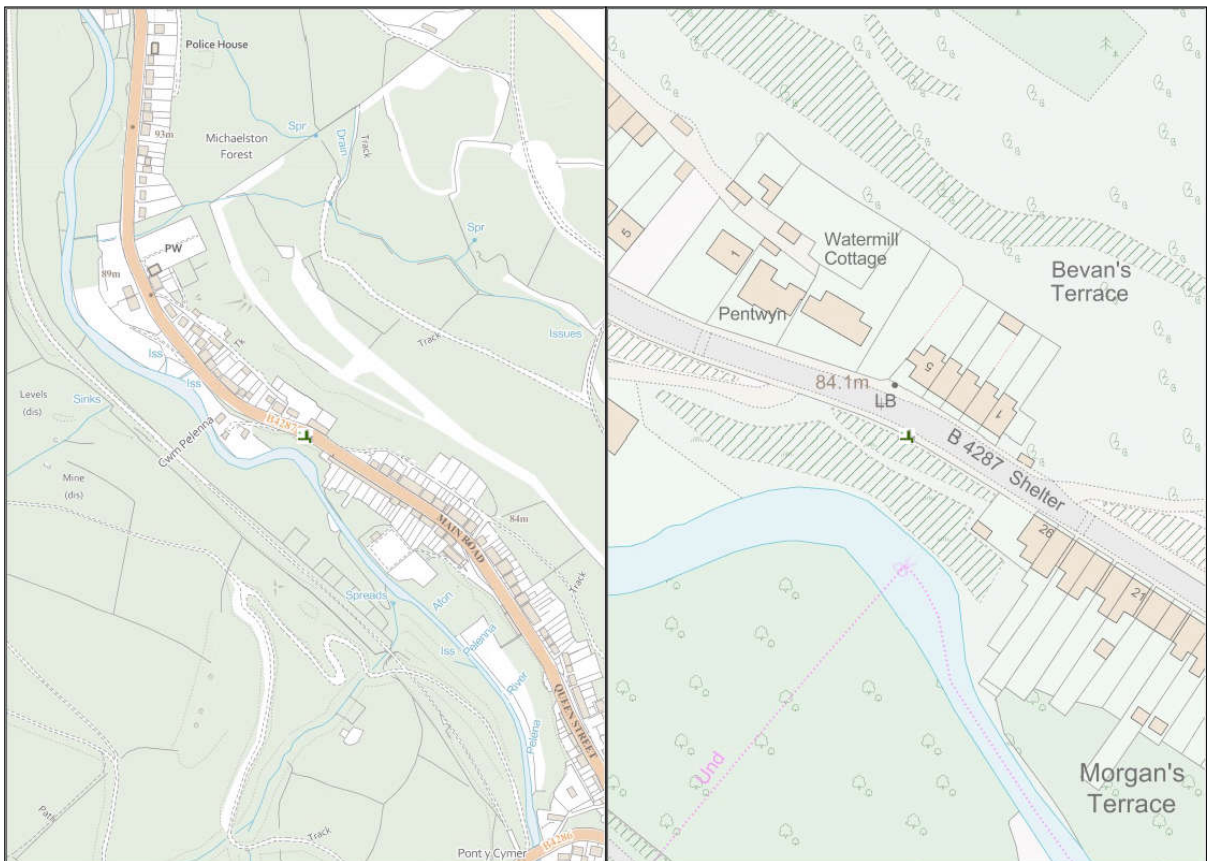
Map Ref:	OS:	SS79029467			Primary Str. Form:				
Width:	60	Length:	0.65		Primary Material:		B		
All Above Ground Elements Inspected:			Yes		Secondary Str. Form:				
					Secondary Material:				
Set	No	Element Description	S	Ex	Def	W	P	Cost	Comments/Remarks
Main Els.	1	Foundations	4	C	6.1		H	£0	There are large sections were it appears that there are no or very limited foundations
	2	Retaining Wall (Primary)	4	C	3.7	N	H	£250,000	The concrete dwarf wall is heavily cracked and is bulging. it has partially collapses at one location and a major dip in footpath and roadway adjacent to no 5 for a section of 10m this section requires replacing as asap as there is no support to the footpath and roadway.
Safety Elements	10	Carriageway	4	C	9.6		M	£150,000	Heavy longitudinal cracking and deformation in the road opposite no 5 where the concrete wall has partially collapsed
	12	Footway/Verge	4	C	3.7	R	H	£25,000	There is cracking to the footpath surfacing throughout the length of the wall but there is a significant deformation above the area where the wall has partially collapsed.

Other Elements	14	Concrete Posts	4	C	3.7	R	M	£50,000	These are substandard by design. 6 no of concrete posts leaning towards river these need replacing with new concrete plinth of 10m
	15	Chain link Fencing	1	A	1.2		N	£0	Good condition
S- Severity ,Ex - Extent, def - Defect. W - Work Required, P - Work Priority, Cost - Cost of work

No.	Comments	Comment Type		
	The wall needs to be rebuilt along with the footpath & the adjacent carriageway	Engineers Comment		
	The concrete plinth has given way causing cracking and a major dip in footpath and roadway adjacent to no 5 for a section of 10m this section requires replacing as asap as there is no support to the footpath and carriageway.	Inspectors Comment		
Name	David Griffiths	Signed	Date	05/04/2022 00:00

Ref No.	Item No.	Work Description	Priority	Estimated Cost	Work Ordered
MA2200060	14	These are substandard by design. 6 no of concrete posts leaning towards river these need replacing with new concrete plinth of 10m	M	£50,000	
MA2200057	12	There is cracking to the footpath surfacing throughout the length of the wall but there is a significant deformation above the area where the wall has partially collapsed.	H	£25,000	
MA2200059	10	Heavy longitudinal cracking and deformation in the road opposite no 5 where the concrete wall has partially collapsed	M	£150,000	
MA2200058	2	The concrete dwarf wall is heavily cracked and is bulging. it has partially collapses at one location and a major dip in footpath and roadway adjacent to no 5 for a section of 10m this section requires replacing as asap as there is no support to the footpath and roadway.	H	£250,000	
Name		Signed		Date
