Gelli Houses Disused Railway  
Tunnel: Cymmer Division

General Inspection

Inspection Type: General Inspection	Form No.: 1 of 2	Description: Span 1 - Brick Lined
Inspector: Paul Ransome	Date: 12/06/2021 00:00	Next Inspection:
Name: Gelli Houses Disused Railway Tunnel (815)	Road Ref:

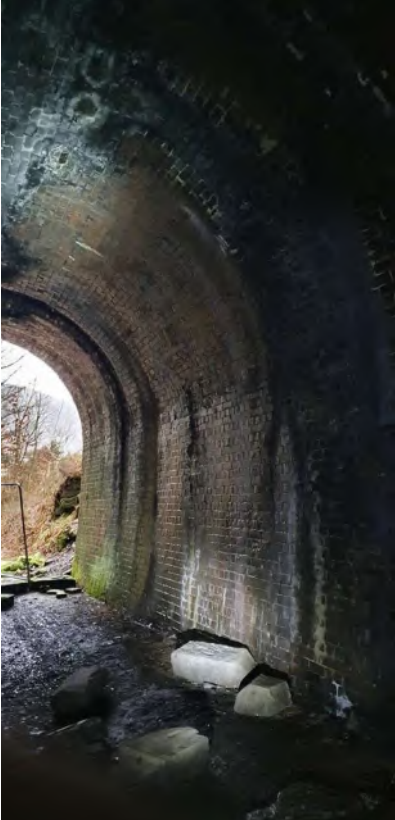
Primary Deck Element

No.	Comments	Comment Type		
9	Pointing is sound with only very minor areas of seepage. The bricks are in a good condition with no delamination or blistering.	Inspectors Comment		
10	Moderate vegetation growth. Some small trees. Small area of stone loss due to vegetation growth to the north west corner of the spandrel.	Inspectors Comment		
23	There is no edge protection on top of the northern portal. The access to this area is difficult with heavy vegetation but there is a potential for members of the public or inspection staff falling over the edge.	Inspectors Comment		
33	There are some large trees growing on top of the tunnel. At the portal end the depth of cover is not great so the tree roots could potentially affect the structure.	Inspectors Comment		
Name	Paul Ransome	Signed	Date	19/02/2021 00:00

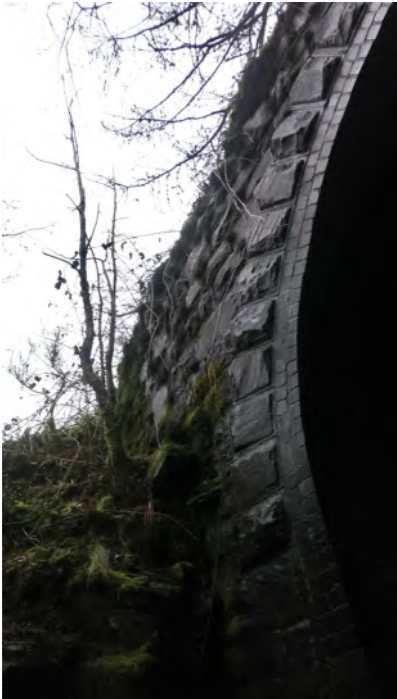
Spandrel wall/head wall
10	2101847

Element No.	S	Ex	Defect	Comments
10	3	C	5.1	Moderate vegetation growth. Some small trees.
1	1	A	3.6	The bricks are in a good condition with no delamination or blistering.

Ref No.	Item No.	Work Description	Priority	Estimated Cost	Work Ordered
MA2100033	10	Small area of stone loss due to vegetation growth to the north west corner of the spandrel	L	£1,000	
PA2100011	23	There is no edge protection on top of the northern portal. The access to this area is difficult with heavy vegetation but there is a potential for members of the public or inspection staff falling over the edge.	M	£5,000	
RE2100009	9	Pointing is sound with only very minor areas of seepage. The bricks are in a good condition with no delamination or blistering.	L	£5,000	
VE2100049	33	There are some large trees growing on top of the tunnel. At the portal end the depth of cover is not great so the tree roots could potentially affect the structure.	M	£2,500	
VE2100050	10	Moderate vegetation growth. Some small trees.	M	£2,500	
Name		Signed	Date
