A Report of the Democratic Services Committee Task and Finish Group: Disability Audit of Neath and Port Talbot Civic Centres

March 2020

Neath Port Talbot County Borough Council

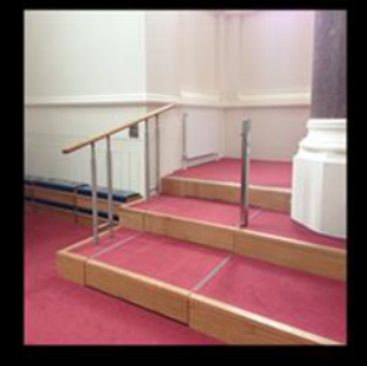
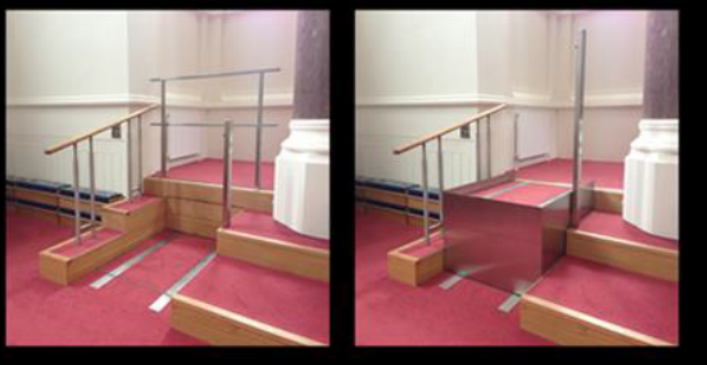
overly steep ramp, which is not reasonable.	new balustrade, in order to give plenty circulation (at present the level is split). The ramp outside the room should remain, as it could feasibly form a means of (assisted) escape, subject to a suitable strategy being in place.					
24	Other levels in the Council Chamber are also stepped, but there is no suitable location for a standard platform lift since it would block the aisle(s).	Carry out feasibility study with a view to providing a Sesame-type platform lift (see photo for similar product). See appendices for details.	4	Ex	As above (No.22)		
25
